SITE NUMBER AND NAME: S067-I and II Sparrowhawk Rockfalls		HIGHWAY & KM: 25291:02, 11.761 to 12.816	PREVIOUS INSPECTION DATE: None	INSPECTION DATE: May 17, 2022	
LEGAL DESCRIPTION:	NAD 83 COORDINATES: UTM Northing Easting		RISK ASSESMENT:		
S067-I: NE-10-23-10-M5	11	5645143 618432	PF: 5	CF: 4	TOTAL: 20
S067-II: SW-10-23-10-M5	11	5644081 618318	PF: 5	CF: 4	TOTAL: 20
AVERAGE ANNUAL DAILY TRAFFIC (AADT): 220 (north) & 360 (south) (Reference No. 70000955 & 70000954)			CONTRACTOR MAINTENANCE AREA (CMA): 28

PROJECT
 SOUTHERN REGION GEOHAZARD RISK MANAGEMENT PROGRAM

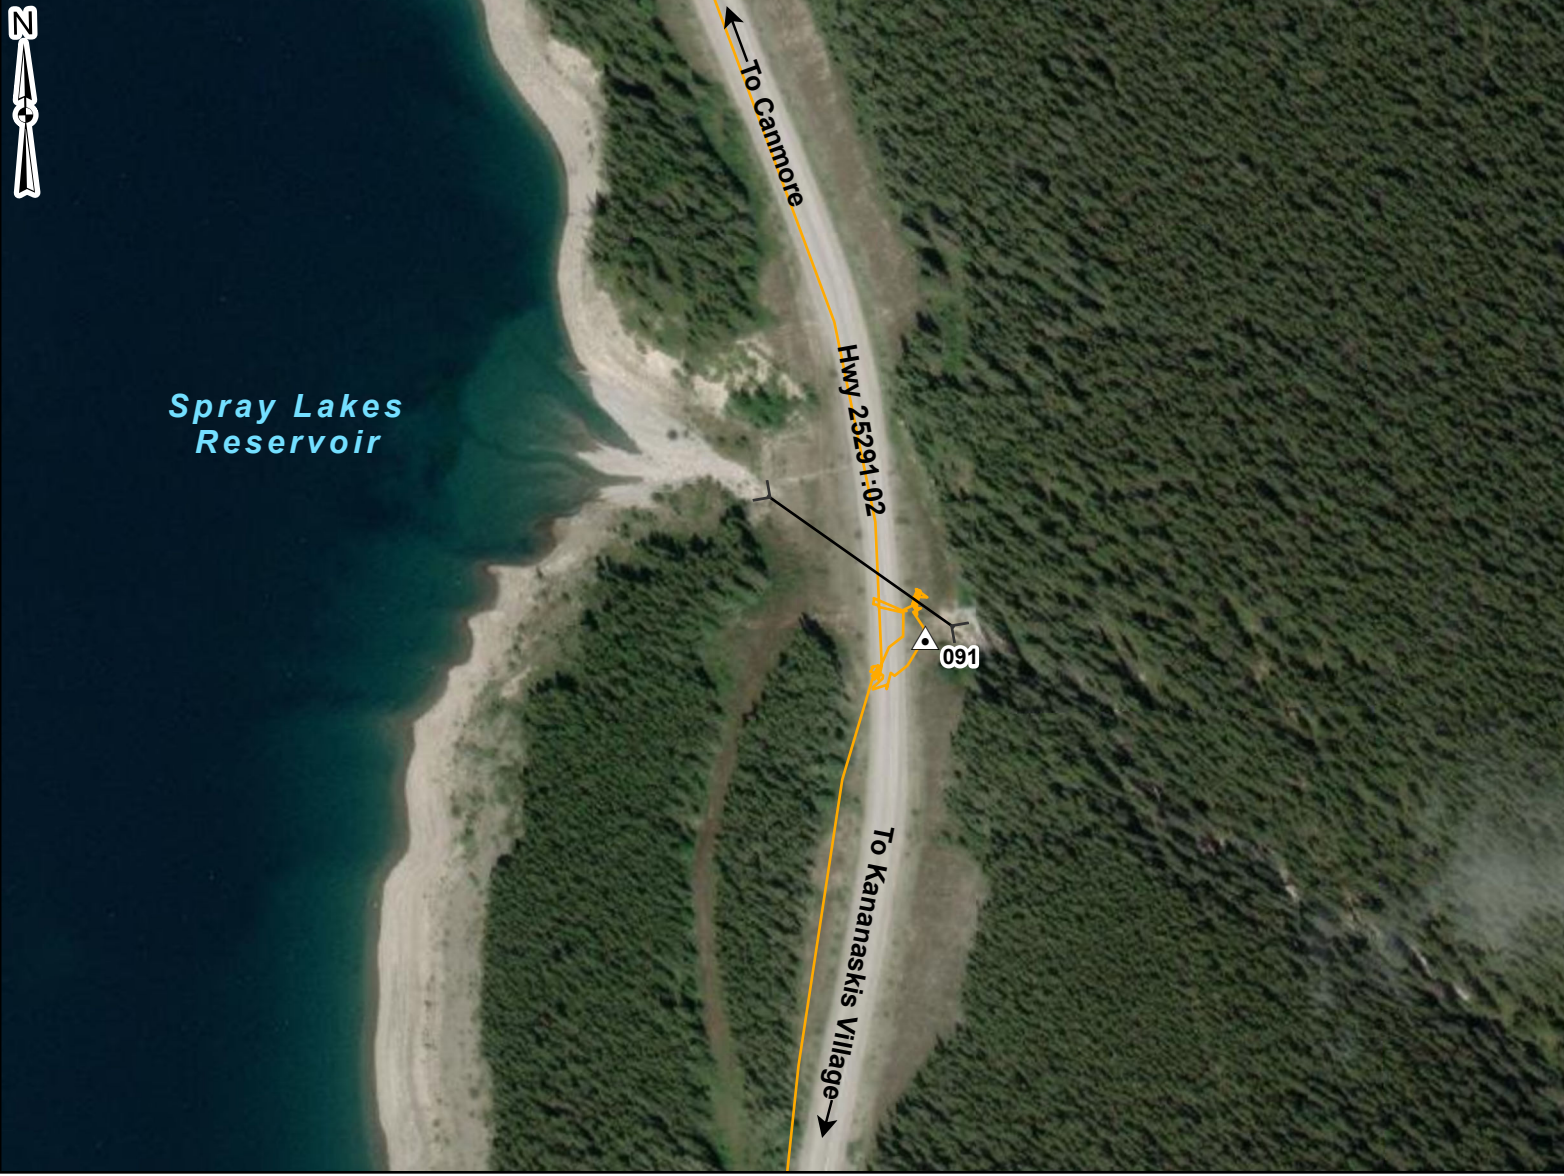
SCALE 1:3,000 PROJECT No. A05116A03 FIG No. 1

COMMENTS
S067-I <ul style="list-style-type: none"> Consists of a bridge size CSP culvert (2 m in diameter) under the highway east of Spray Lakes Reservoir. The culvert appears to be in good condition and was open and conveying water during the 2022 inspection. Concrete wingwalls are installed at the culvert inlet. KCB believes there is risk of debris flow from Sparrowhawk Mountain could potentially block the culvert inlet. No concerns were noted regarding the highway embankment during the 2022 inspection.
S067-II: <ul style="list-style-type: none"> Consists of a bridge size culvert (2 m in diameter) under the highway east of Spray Lakes Reservoir. The culvert inlet is armoured with a concrete wing wall. Some erosion riling was noted along the northeast corner of the east embankment. The culvert appears to be in good condition but was partially filled with ice

TITLE
 Site Plan
 S067-1 - Sparrowhawk Rockfall Hazards
 Hwy 25291:01, km 12.816

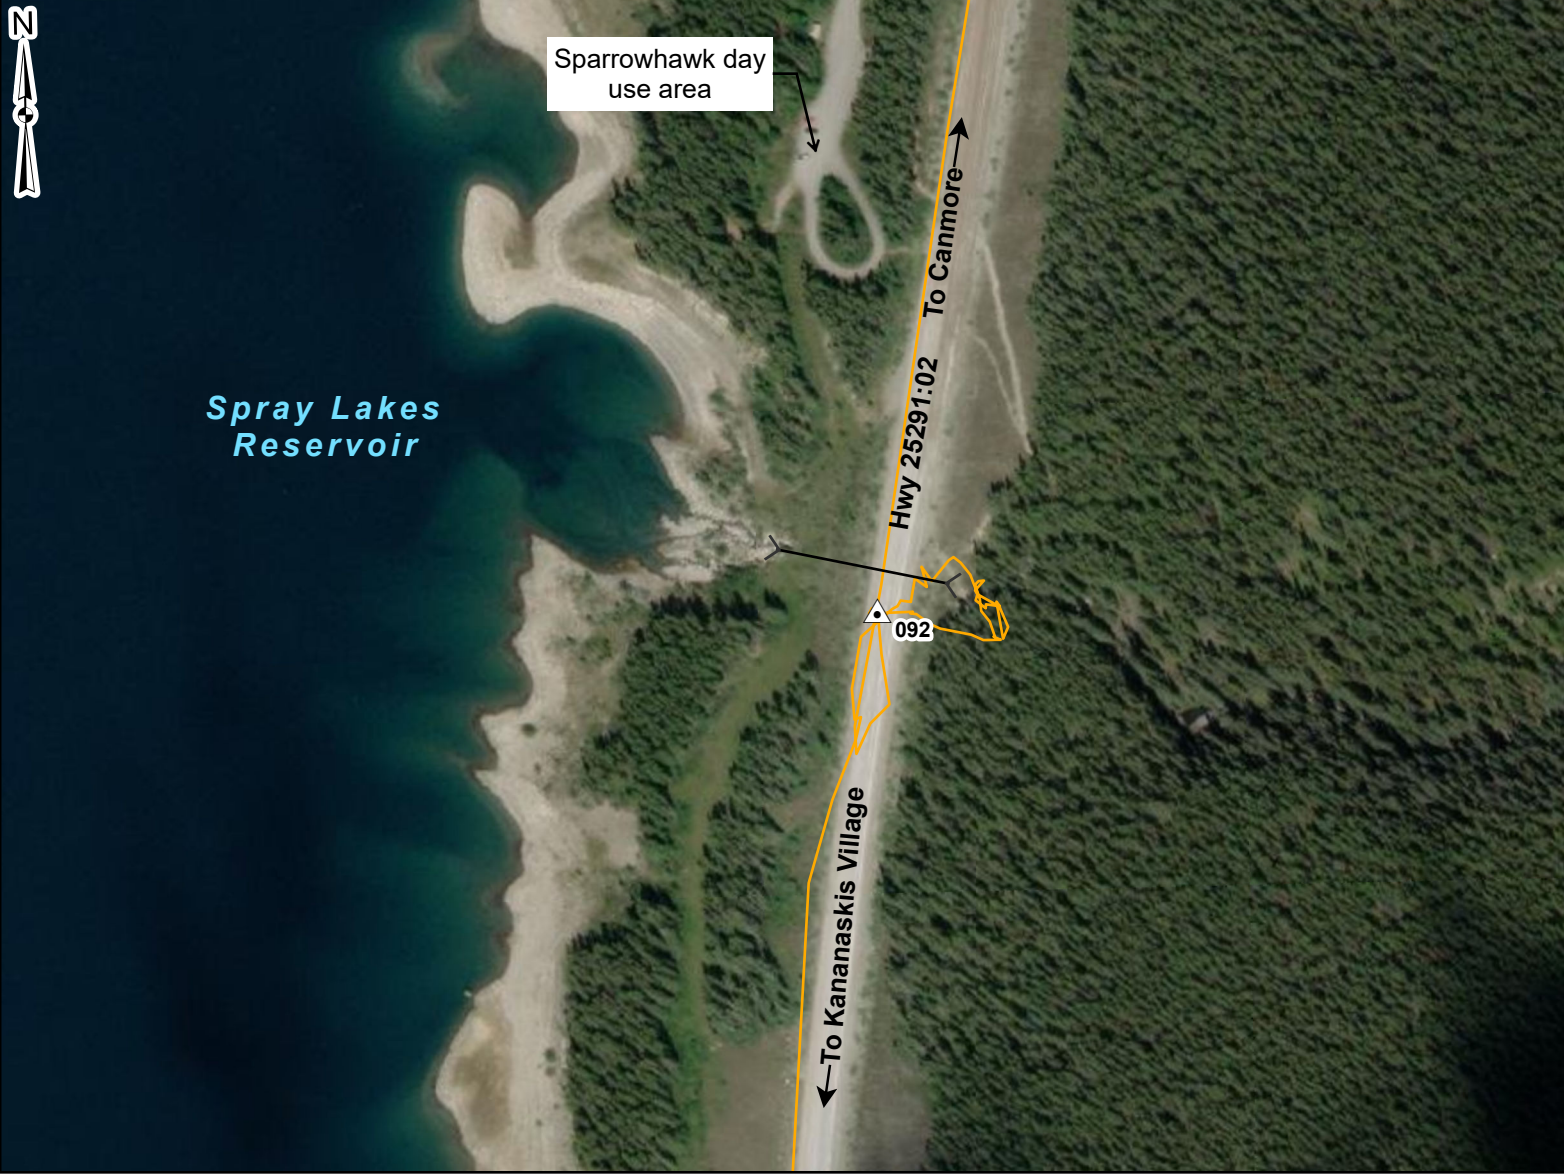
SCALE 1:3,000 PROJECT No. A05116A03 FIG No. 1

TITLE
 Site Plan
 S067-2 - Sparrowhawk Rockfall Hazards
 Hwy 25291:01, km 11.761
