## **SECTION B – SITE VISIT AND ASSESSMENT**

### **2007 SITE INSPECTION**

PROJECT: SOUTHERN REGION GEOHAZARD ASSESSMENT

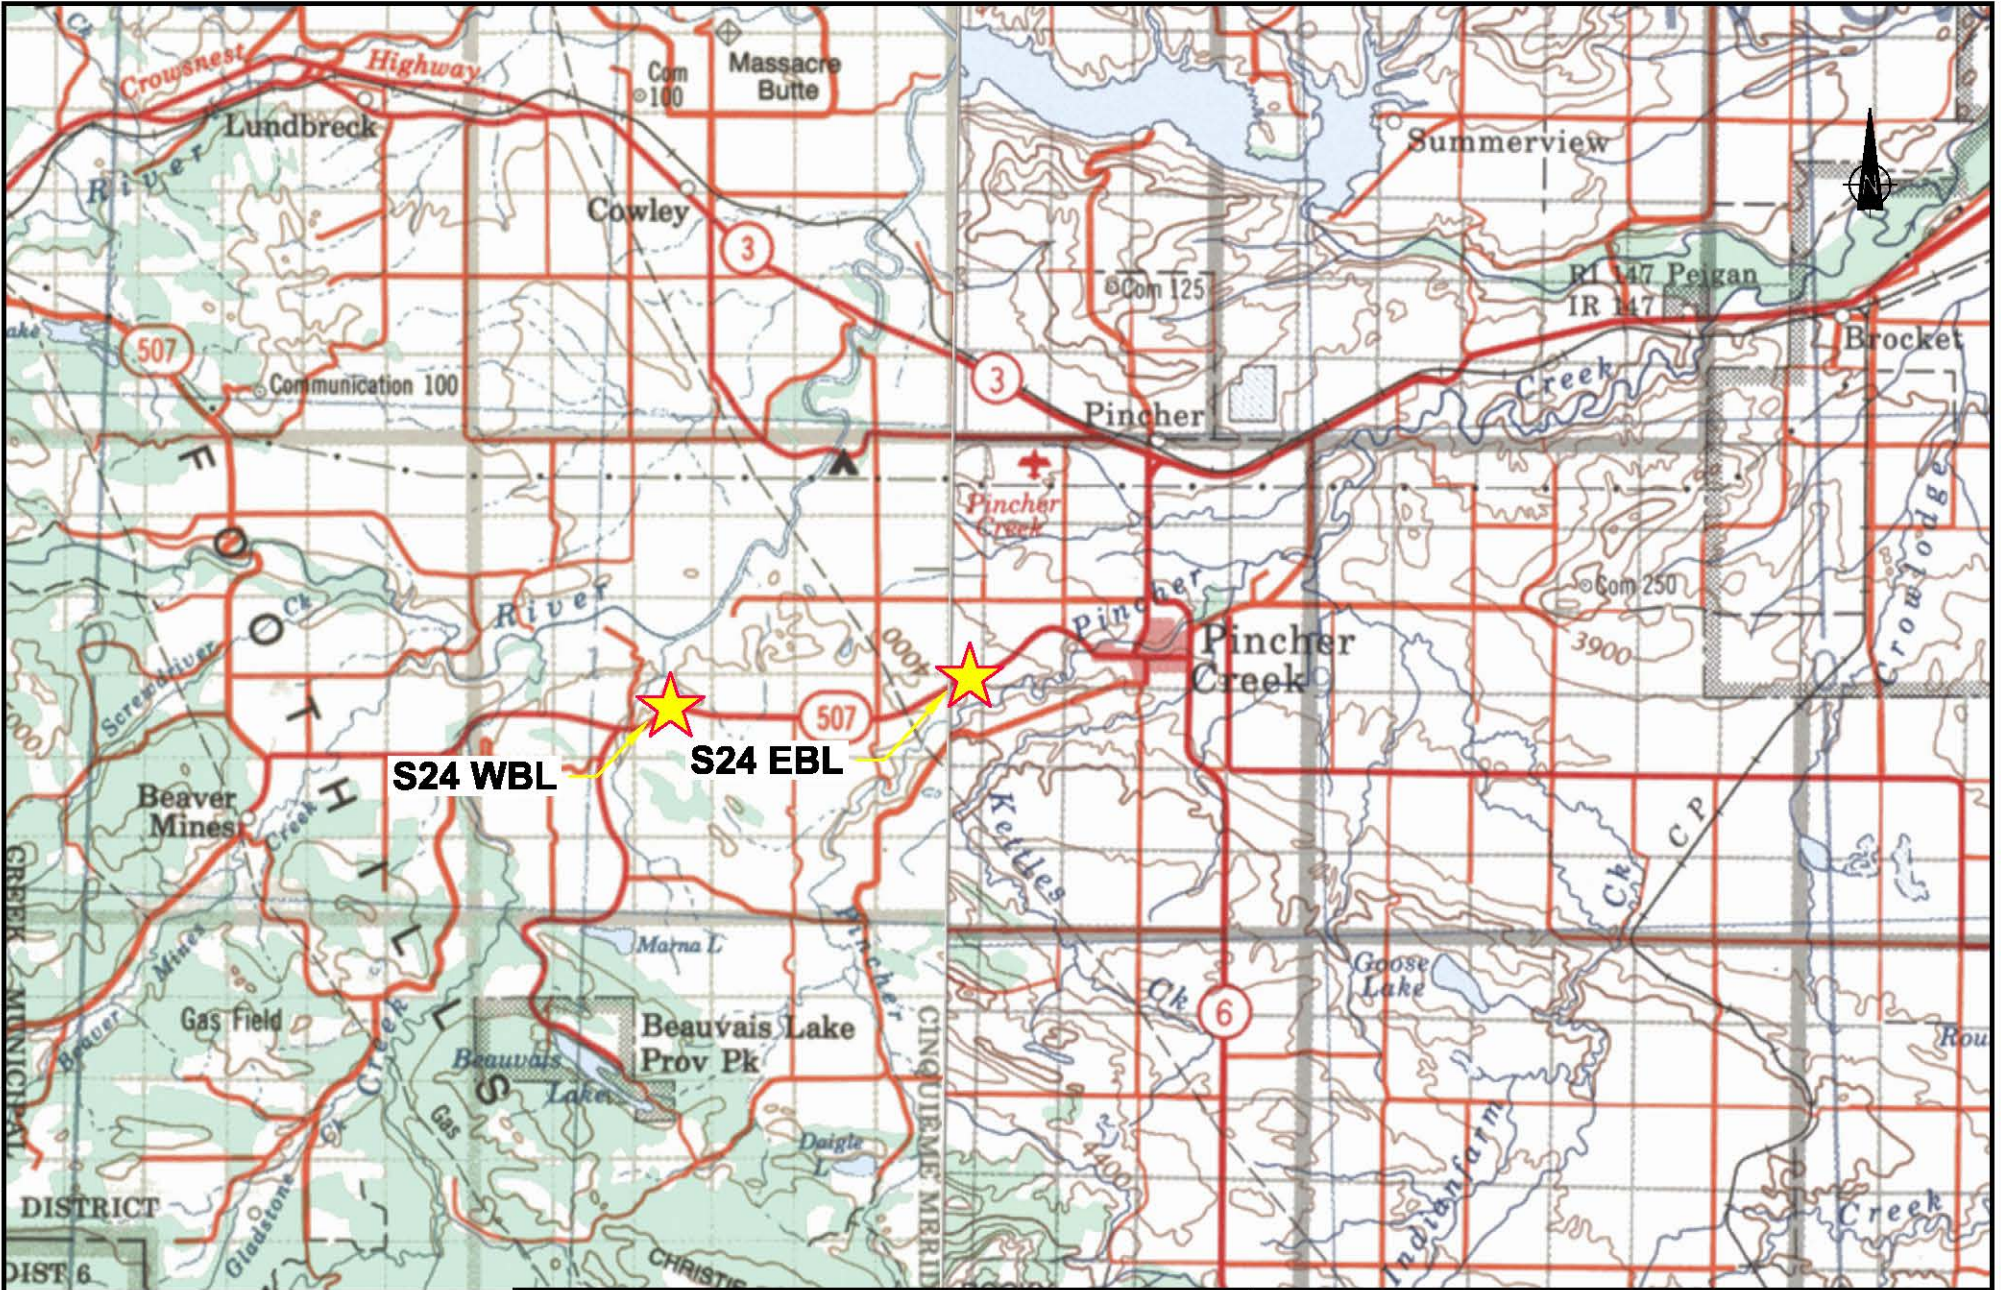
PROJECT: SOUTHERN REGION GEOHAZARD ASSESSMENT				
		TITLE: S24 HWY 507-PLAN VIEW OF EASTBOUND LANE SITE				
CLIENT:		DATE: AUGUST 2007	JOB No.: CG25263	CAD FILE: 25263X00.dwg	FIGURE No.: S24-2	REV. A

The highway is located approximately 500 m north of the channel of Pincher Creek and along the crest of the north Pincher Creek valley slope. This valley is a broad, relatively flat-bottomed valley incised approximately 30 m into a flat upland plain to the west of the town of Pincher Creek, AB. The local segment of the highway is straight along an east/northeast bearing of 074/254 and is approximately tangent to the curving crest of the north valley slope as shown on the plan view of the site, attached as Figure S24-2 in Appendix S24.

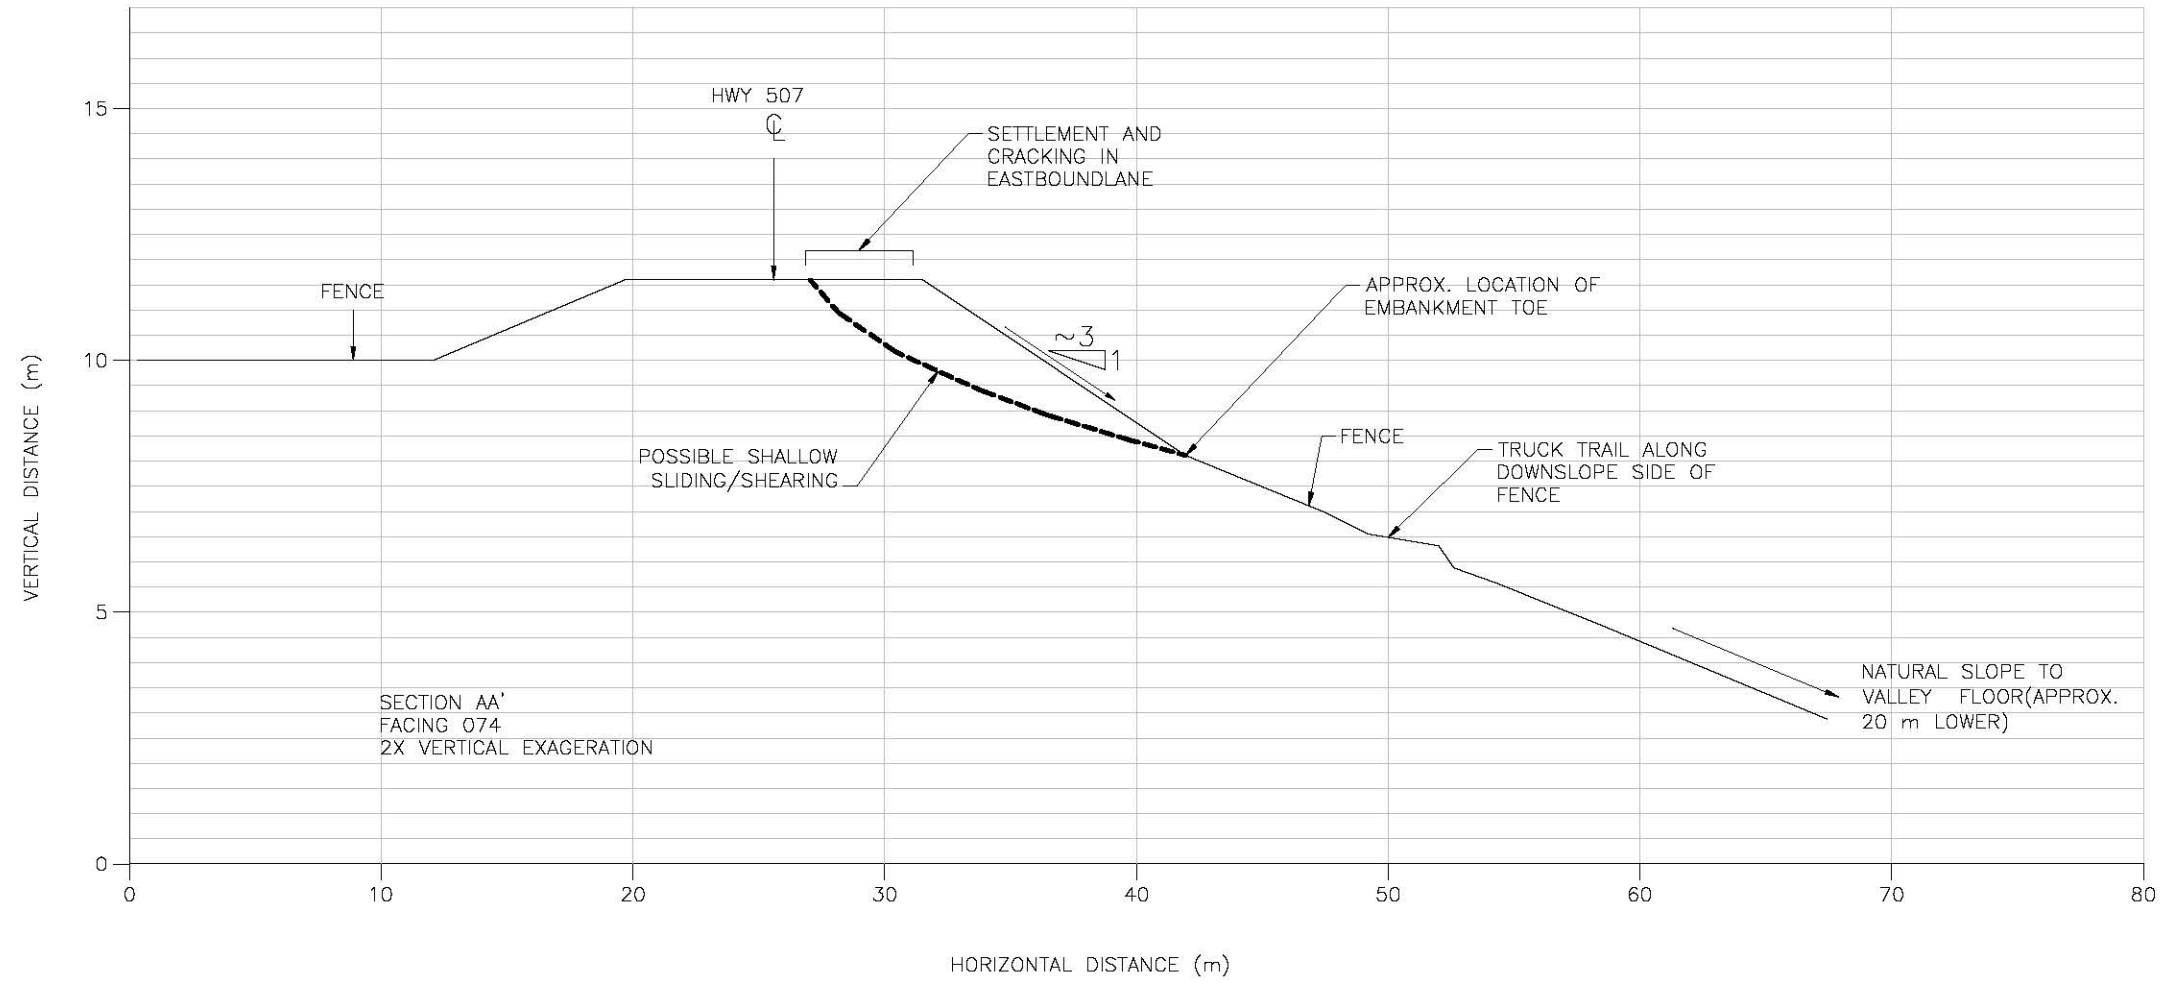
SECTION AA'  
 FACING 074  
 2X VERTICAL EXAGGERATION

- The settlement and cracking area is along an approximately 52 m long segment of the highway and encompasses the entire eastbound lane. This segment consists of a fill embankment approximately 3 to 4 m high that was placed to maintain the road grade across an area where the highway alignment crosses below the crest of the north valley slope and is across the uppermost portion of the valley slope.
- Figure S24-3 in Appendix S24 shows a cross-section through the damaged portion of the highway.
- Based on the road surface appearance at the time of the September 2006 site inspection, it appeared that the maximum vertical settlement prior to patching could have been in the order of 100 mm.
