S13 – SHEEP RIVER SITE

Alberta Transportation
Southern Region Geohazard Assessment
Annual Assessment Report
June 2004

PROJECT: SOUTHERN REGION GEOHAZARD ASSESSMENT

TITLE: SCHEMATIC SITE PLAN
HIGHWAY 546: SHEEP RIVER SITE

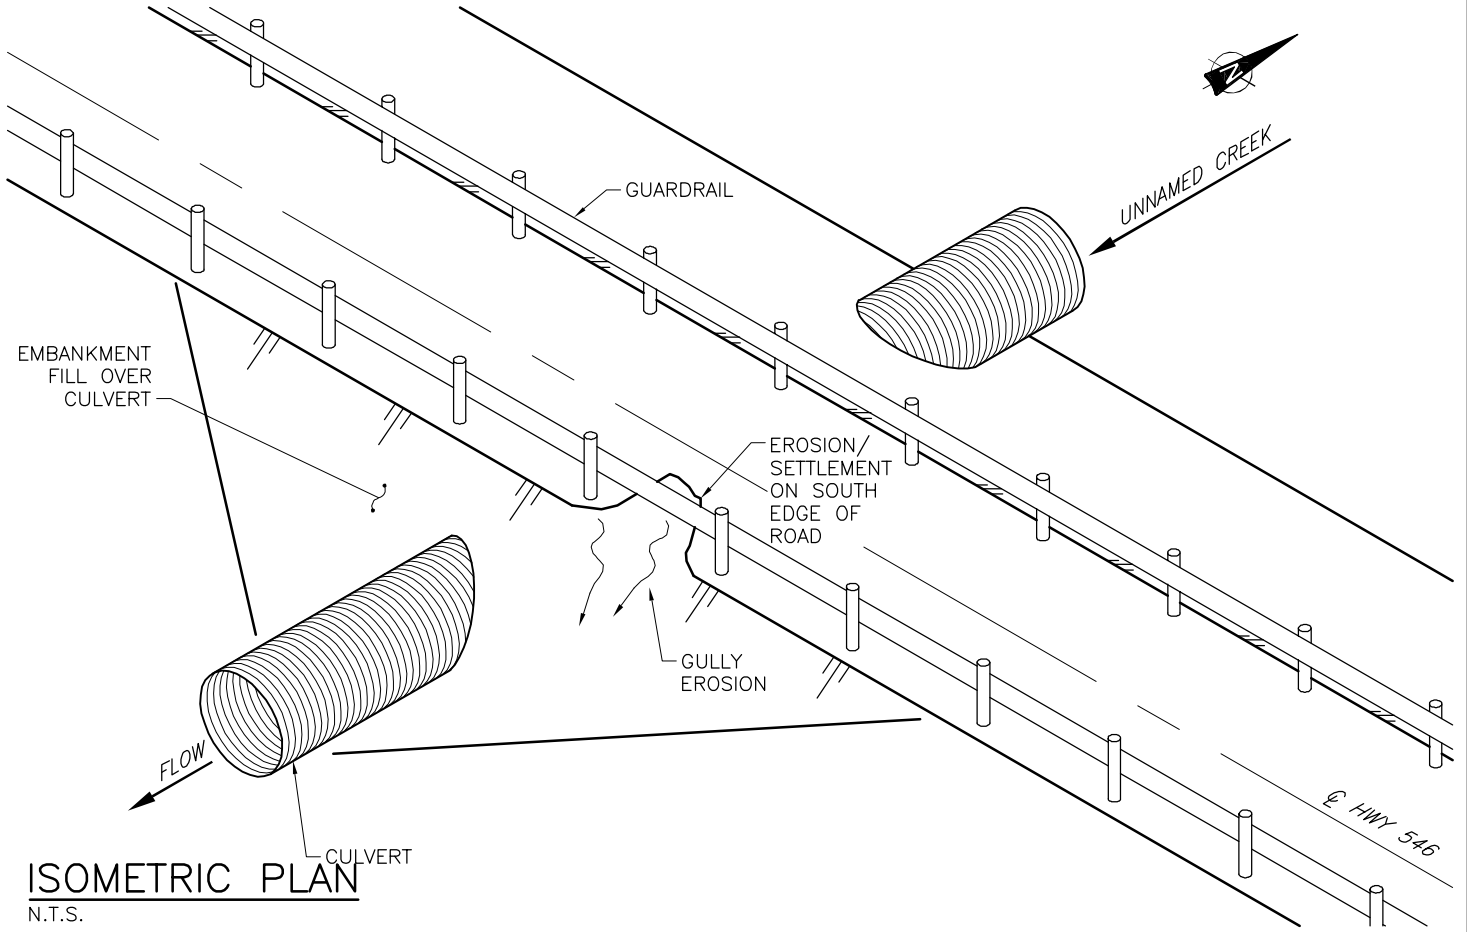
ISOMETRIC PLAN
N.T.S.

- No repair measures have been made to the erosion into the south edge of the road since the 2003 assessment. The previously-noted gulying and surface erosion in the fill embankment slope face downslope (south) of the road has been continuing. The gully erosion has retrogressed slightly further (in the order of 0.5 m or less) into the eastbound lane of the road. Photos S13-1 to S13-4 illustrate the site conditions.
- There was a pile of rockfall debris from a rock cut to the east of this site stockpiled on the area downslope (south) of the guardrail on the east side of the creek, as shown in Photo S13-3. AMEC understands that this has been done in previous years prior to disposing of the debris by bulldozing it into the gully downstream of the road.

roughly estimated to have been less than 5 cm since the July 2003 assessment. Portions of the guardrail have been undermined but the guardrail itself has not been deflected to date. As noted in the 2003 assessment, the road surface is relatively wide at this location and it appears that the portion of the eastbound lane that has been lost to erosion to date is not within the traffic path. However any vehicles that pass close to the south guardrail are at risk of hitting the eroded and slightly undermined area. It is possible that the erosion into the southbound lane could be left unrepaired for several years without significant risk to the eastbound lane, however it would be preferable to repair the current damage, restore the full support to the guardrail posts and prevent it from happening again.

The gullying on the fill slope below the road should be mitigated by improved control of the runoff from the road surface. AMEC recommends the following to achieve this (see Figure 2-S13 in Appendix S13 for a schematic illustration):
