SOUTHERN REGION GRMP SITE INSPECTION FORM

SITE NUMBER AND NAME:		HIGHWAY & KM:		PREVIOUS		INSPECTION DATE:	
S057 Hwy 1A, Exshaw, Sites A & B		1A:02 km 12.52 to		INSPECTION DATE:		July 6, 2020	
	11.91		May 7, 2019		00.19 0, =0=0		
LEGAL DESCRIPTION:	NAD 83 COORDINATES:			RISK ASSESMENT:			
13-22-024-09 W5M	UTM	Northing	Easting	PF: 11	CF: 1	TOTAL: 11 (Site A)	
	11	5658509	627178	PF: 11	CF: 3	TOTAL: 33 (Site B)	
AVERAGE ANNUAL DAILY TRAFFIC:				CONTRACTOR MAINTENANCE AREA (CMA):			
844 (west), 770 (east) (Ref. No. 50100258)				27

PRIMARY SITE ISSUE: Two rock cut slopes with bedding planes dipping towards the highway. The sites have shallow to non-existent catchment ditches and rockfalls can reach the highway.

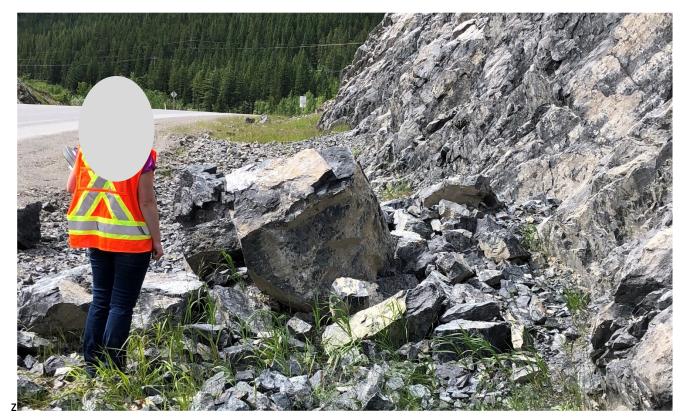
Rockfalls are active and unweathered rockfall debris (up to $0.5 \text{ m} \times 0.65 \text{ m} \times 0.75 \text{ m}$) was noted in the ditch at Site B. Multiple potential loose blocks were visible in the rock mass.

Photo 5 Rockfall debris up to 0.25 m³ in the ditch of Site B. Photo was taken facing northwest on July 6, 2020.

- routine inspection of the slope.
- excavation of rockfall catchment ditches adjacent to the highway and spot bolting of blocks which appear
 unstable or pose a wedge failure risk. A trajectory model could be used to determine the size of lock
 block wall required to contain the rockfalls.
- a lock block wall or HTCB could be considered but the impact in wildlife movement and road safety would need to be evaluated.
