November 29, 2024

**Alex Frotten, P.Eng.**  
**Construction Engineer – Delivery Services Division (Southern Region)**

**CON0022161 Southern Region GRMP Instrumentation Monitoring**  
**Site S004; H02:08, km 6.284 Willow Creek**  
**Section C – 2024 Fall Readings**

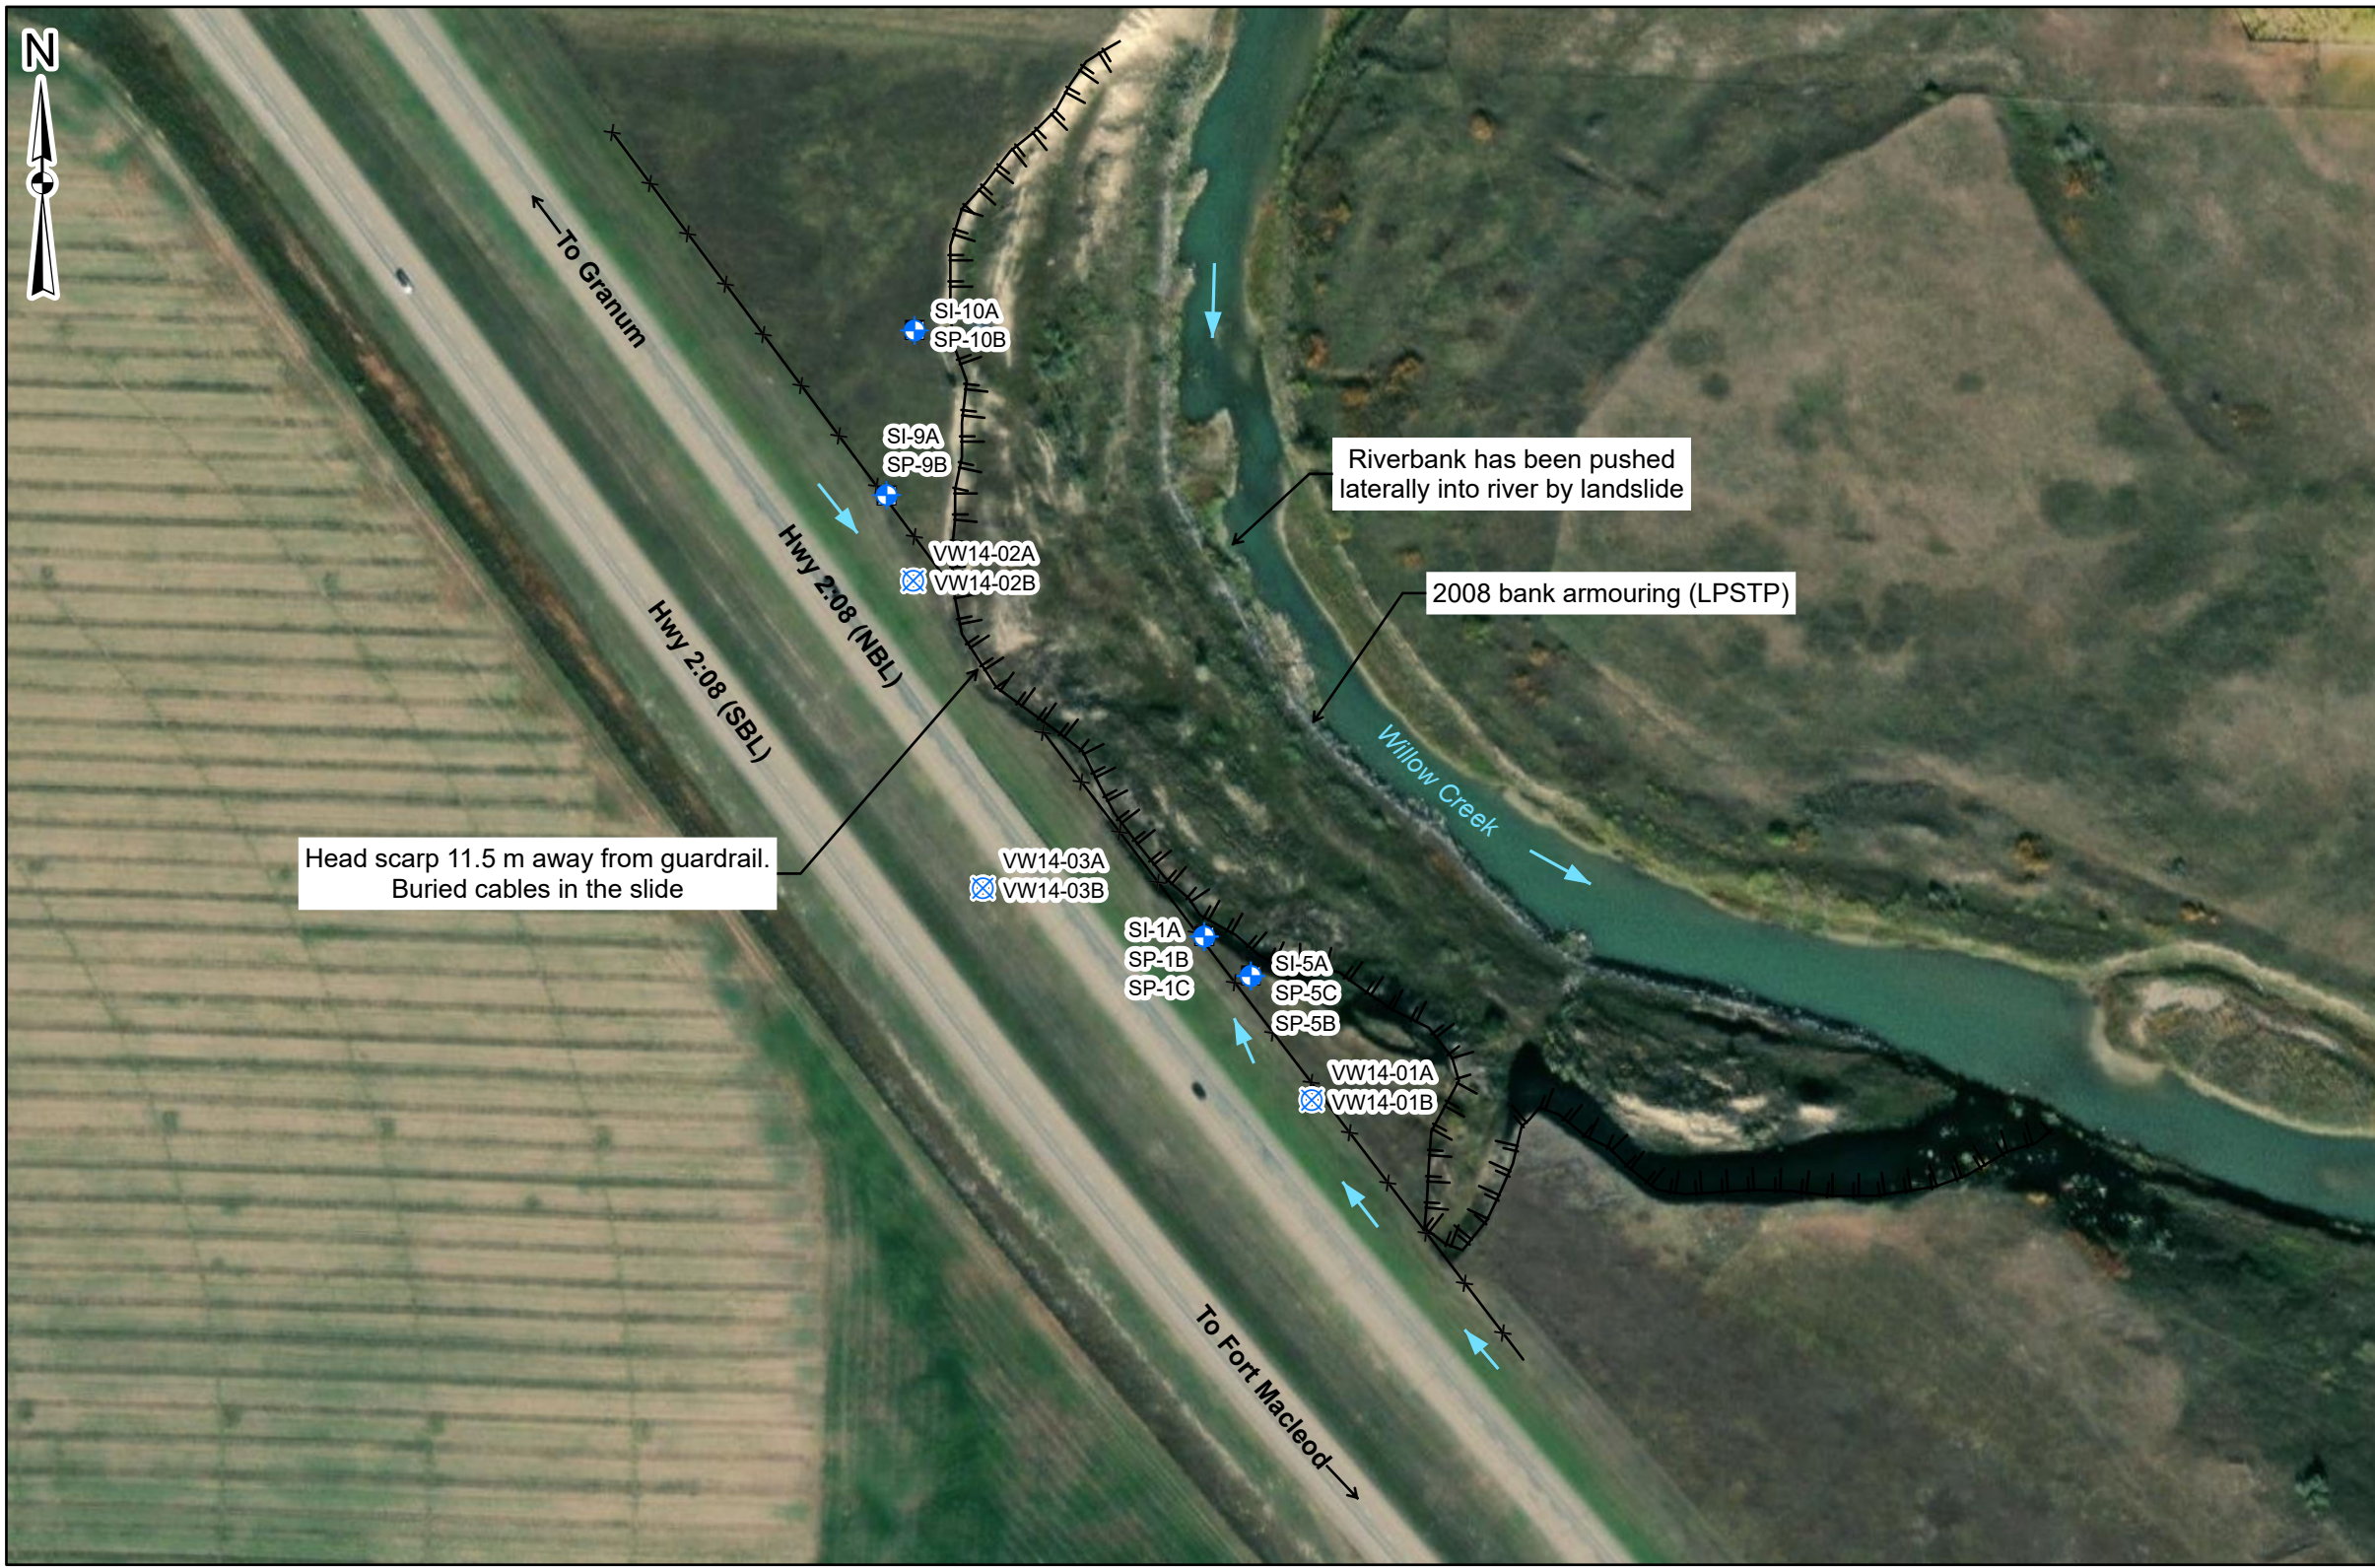
PROJECT SOUTHERN REGION GEOHAZARD RISK MANAGEMENT PROGRAM		
TITLE Site Plan S004 - Willow Creek (North of Ft. Macleod) Hwy 2:08, km 6.284		
SCALE 1:2,000	PROJECT No. A05116A03	FIG No. 1

The geohazard at the S004 site consists of a landslide at the outside bend of Willow Creek with the slope crest retrogressing into the northbound lane ditch of Hwy 02:08. Previous remedial actions at the site include soil nailing, grading, bioengineering (live staking), and bank armoring in 2008. A guardrail was also installed in 2014.

The nature of sliding (back tilting blocks) observed on site suggests a combination of rotational failure and failure along a weak layer at depth. The right (south) flank of the slide appears to be retrogressing faster than other areas of the slide.
