September 21, 2022

Alberta Transportation
2nd Floor, 803 Manning Road N.E.
Calgary, Alberta
T2E 7M8

**CON0022161 Southern Region GRMP Instrumentation Monitoring
Site S005; H36:02, km 37.1 Chin Coulee Slide
Section C – 2022 Spring Readings**

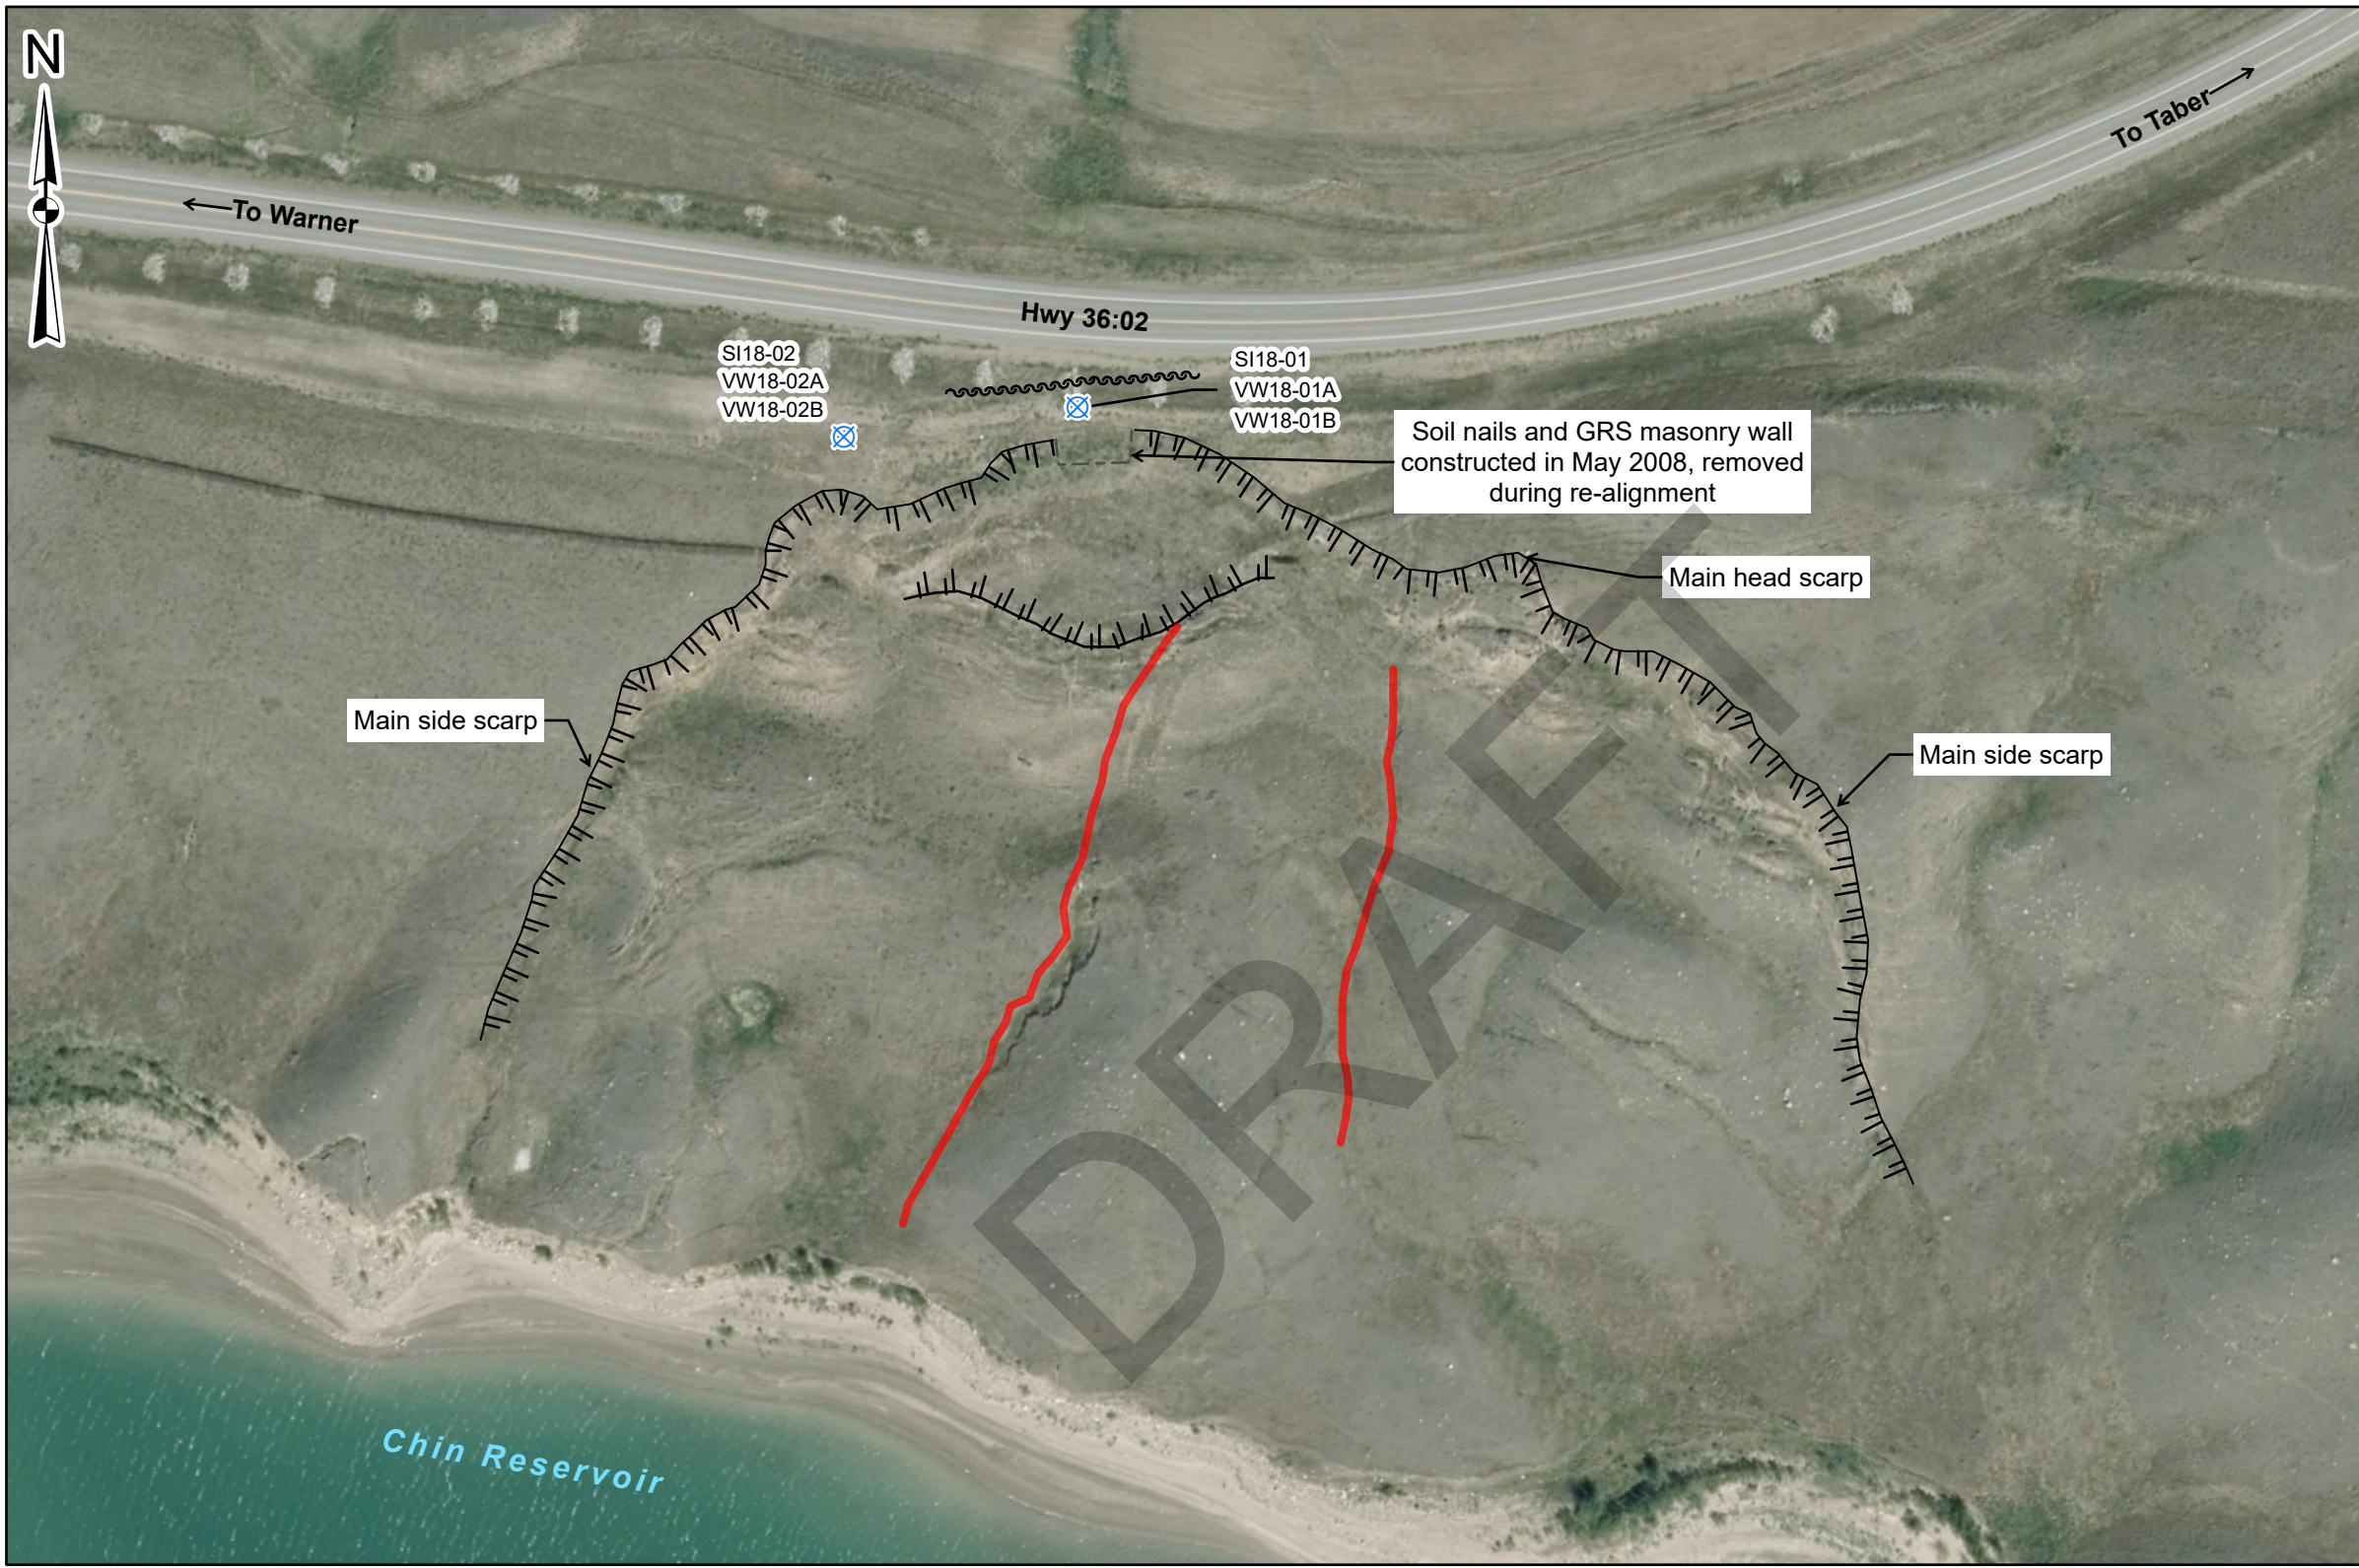
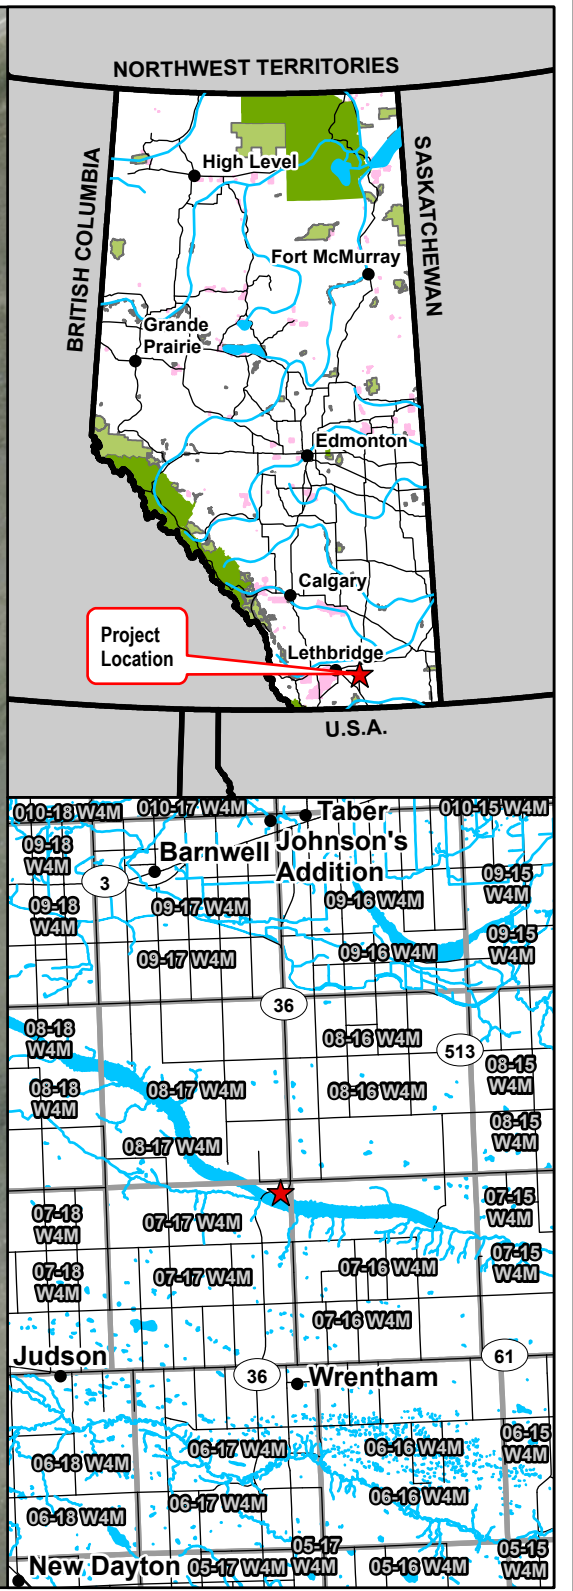
FIGURE

Two slope inclinometers (SIs) (SI18-01 and SI18-02) and four vibrating wire piezometers (VWPs) (VW18-01A/B and VW18-02A/B) were read at the S005 site in Southern Region on July 7, 2022 by Mr. Guerin White, E.I.T., of Klohn Crippen Berger Ltd. (KCB). These instruments were read as part of the Southern Region Geohazard Risk Management Program (GRMP). The site is located on Hwy 36:02 km 37.1, approximately 19 km south of Taber, Alberta, and approximately 500 m east of Chin Coulee Bridge. The approximate site coordinates are 5495444 N, 441404 E (UTM Zone 12, NAD 83) and the legal land description for the site is NW 36-07-17-W4. A site plan is presented in Figure 1.

Instrumentation installation details are tabulated in Table 1.1. Instrument locations are shown in Figure 1. Any instruments not included in Table 1.1 or shown in Figure 1 are assumed to be inoperable and are not presented or discussed herein.
