September 21, 2022

Alberta Transportation
2nd Floor, 803 Manning Road N.E.
Calgary, Alberta
T2E 7M8

**CON0022161 Southern Region GRMP Instrumentation Monitoring
Site S026; H41:03, km 35.169 Elkwater Slides
Section C – 2022 Spring Readings**

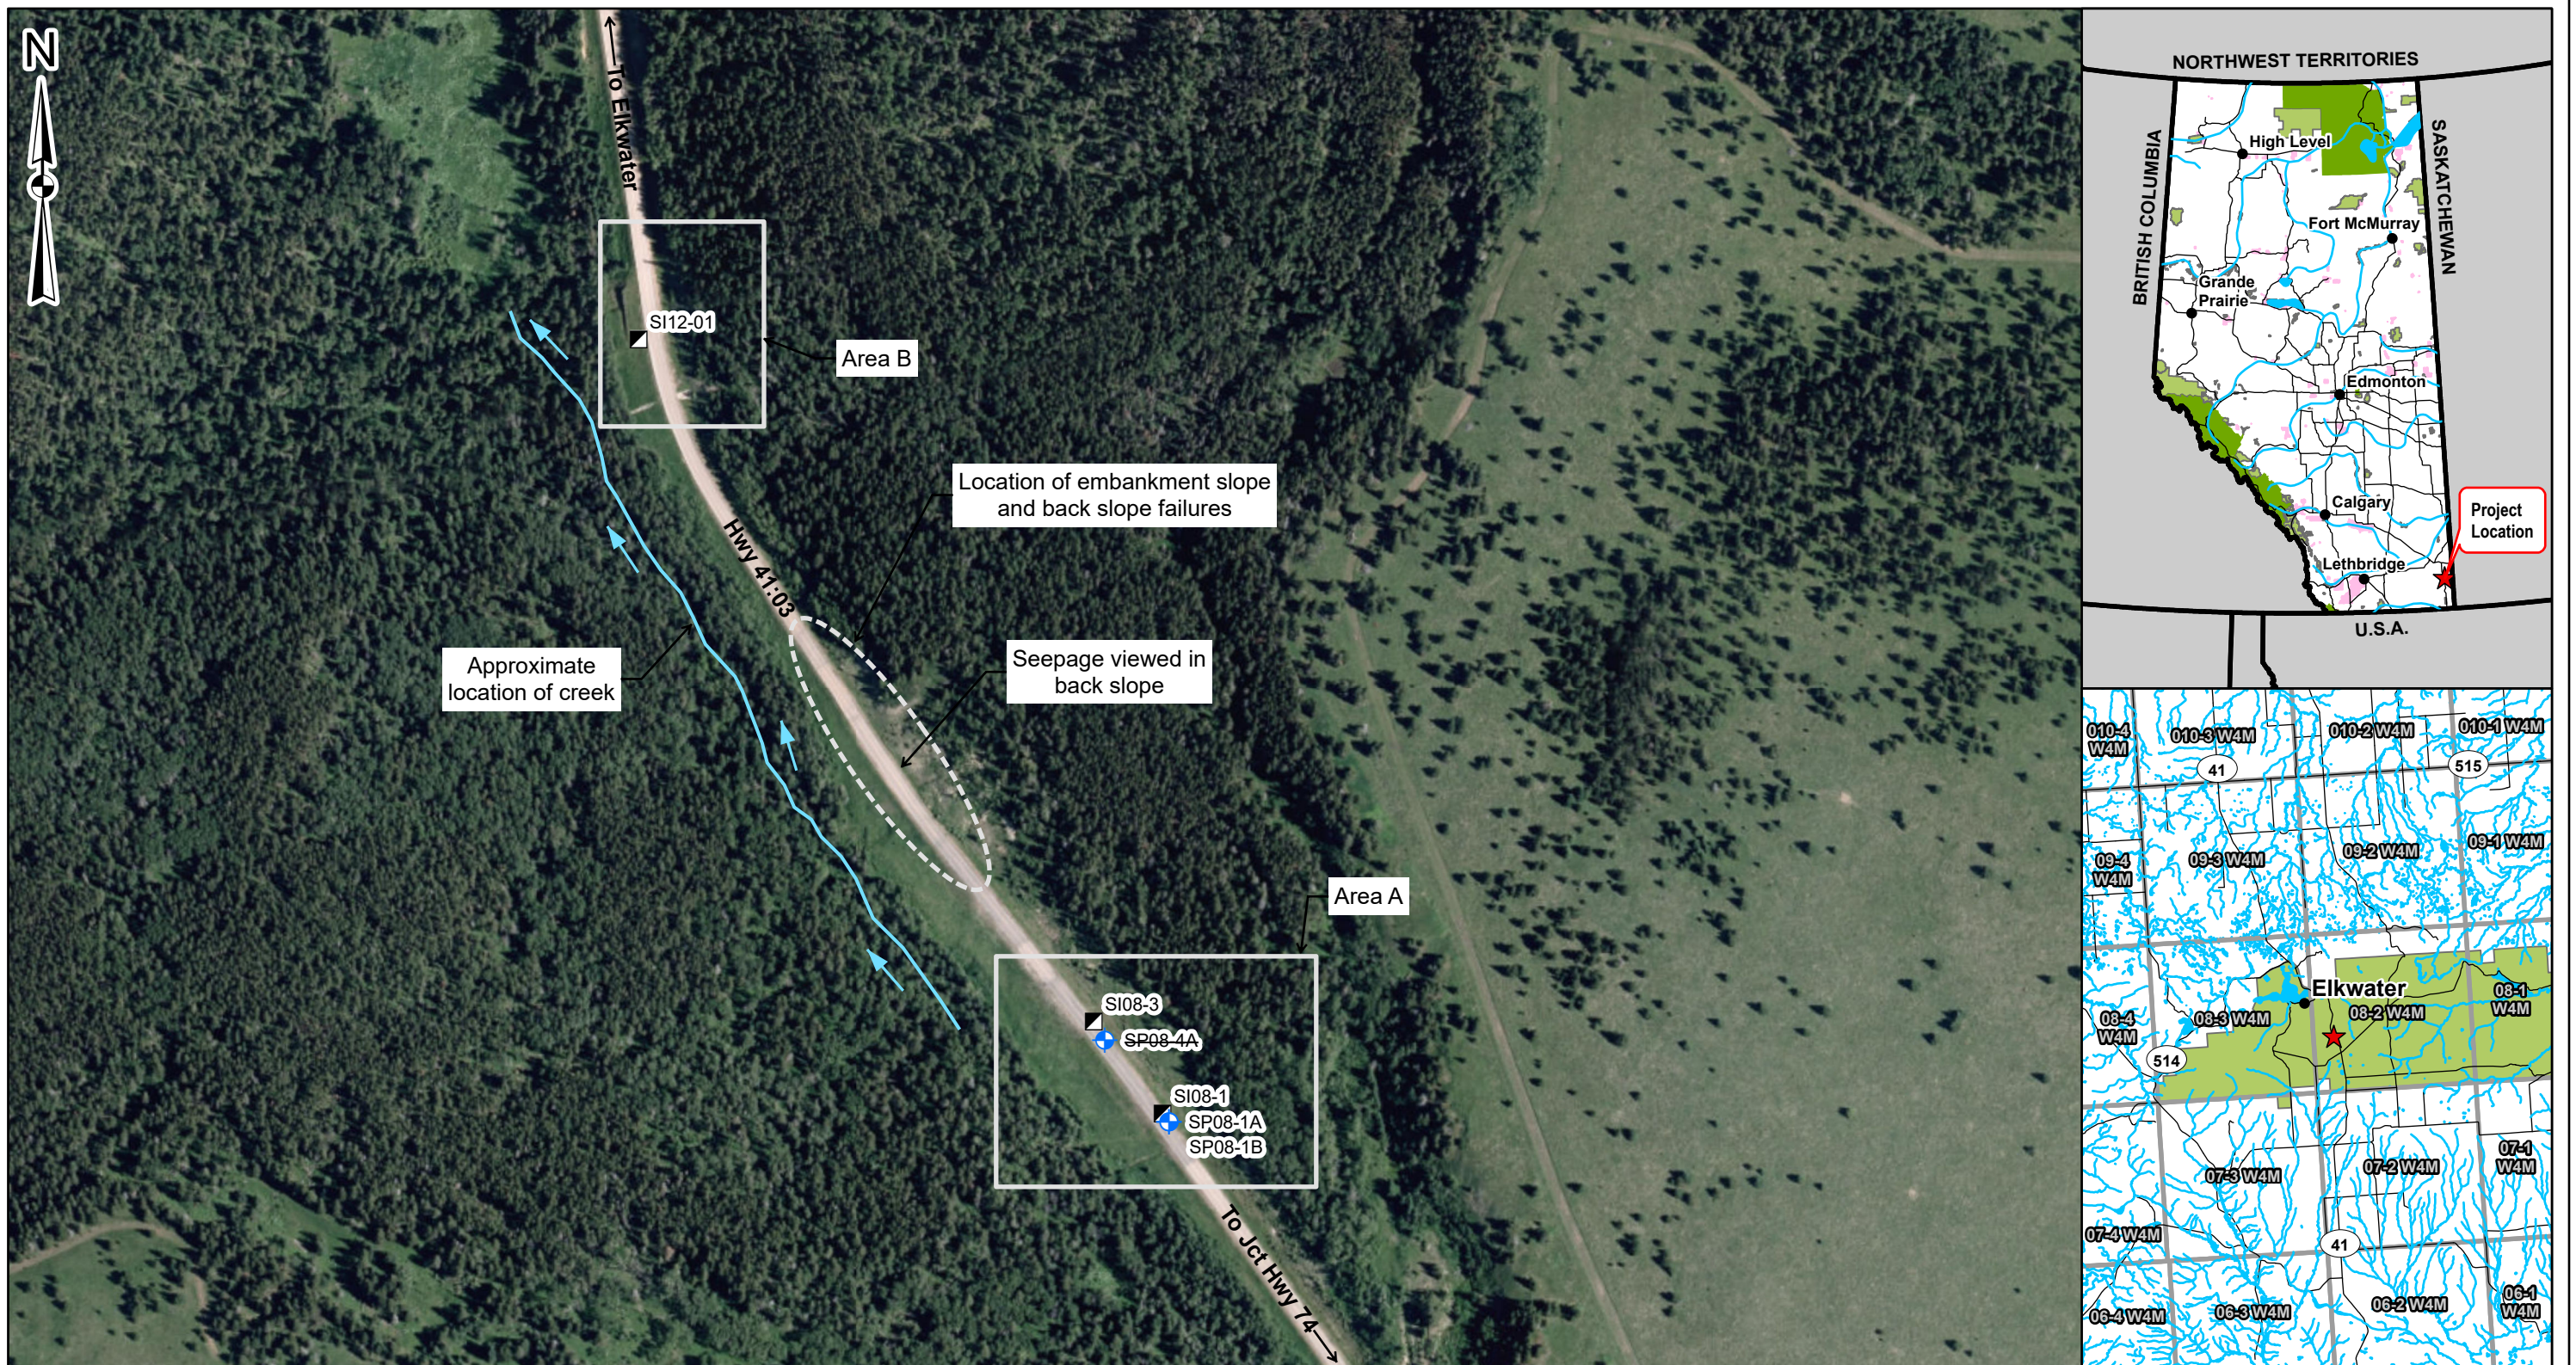
FIGURE

Three slope inclinometers (SIs) (SI08-1, SI08-3, and SI12-1) and two standpipe piezometers (SPs) (SP08-01A and SP08-01B) were read at the S026 site in the Southern Region on July 7, 2022 by Mr. Guerin White, E.I.T. of Klohn Crippen Berger Ltd. (KCB). These instruments were read as part of the Southern Region Geohazard Risk Management Plan (GRMP). The site is located at Hwy 41:03 km 35.2, approximately 4 km south of the turnoff from Hwy 41:03 to the Town of Elkwater, Alberta. The approximate site coordinates are 5499046 N, 553536 E (UTM Zone 12, NAD 83). A site plan is presented in Figure 1.
