July 10, 2024

Alberta Transportation and Economic Corridors  
2<sup>nd</sup> Floor, 803 Manning Road N.E.  
Calgary, Alberta  
T2E 7M8

**CON0022161 Southern Region GRMP Instrumentation Monitoring  
Site S026; H41:03, km 35.169 Elkwater Slides  
Section C – 2024 Spring Readings**

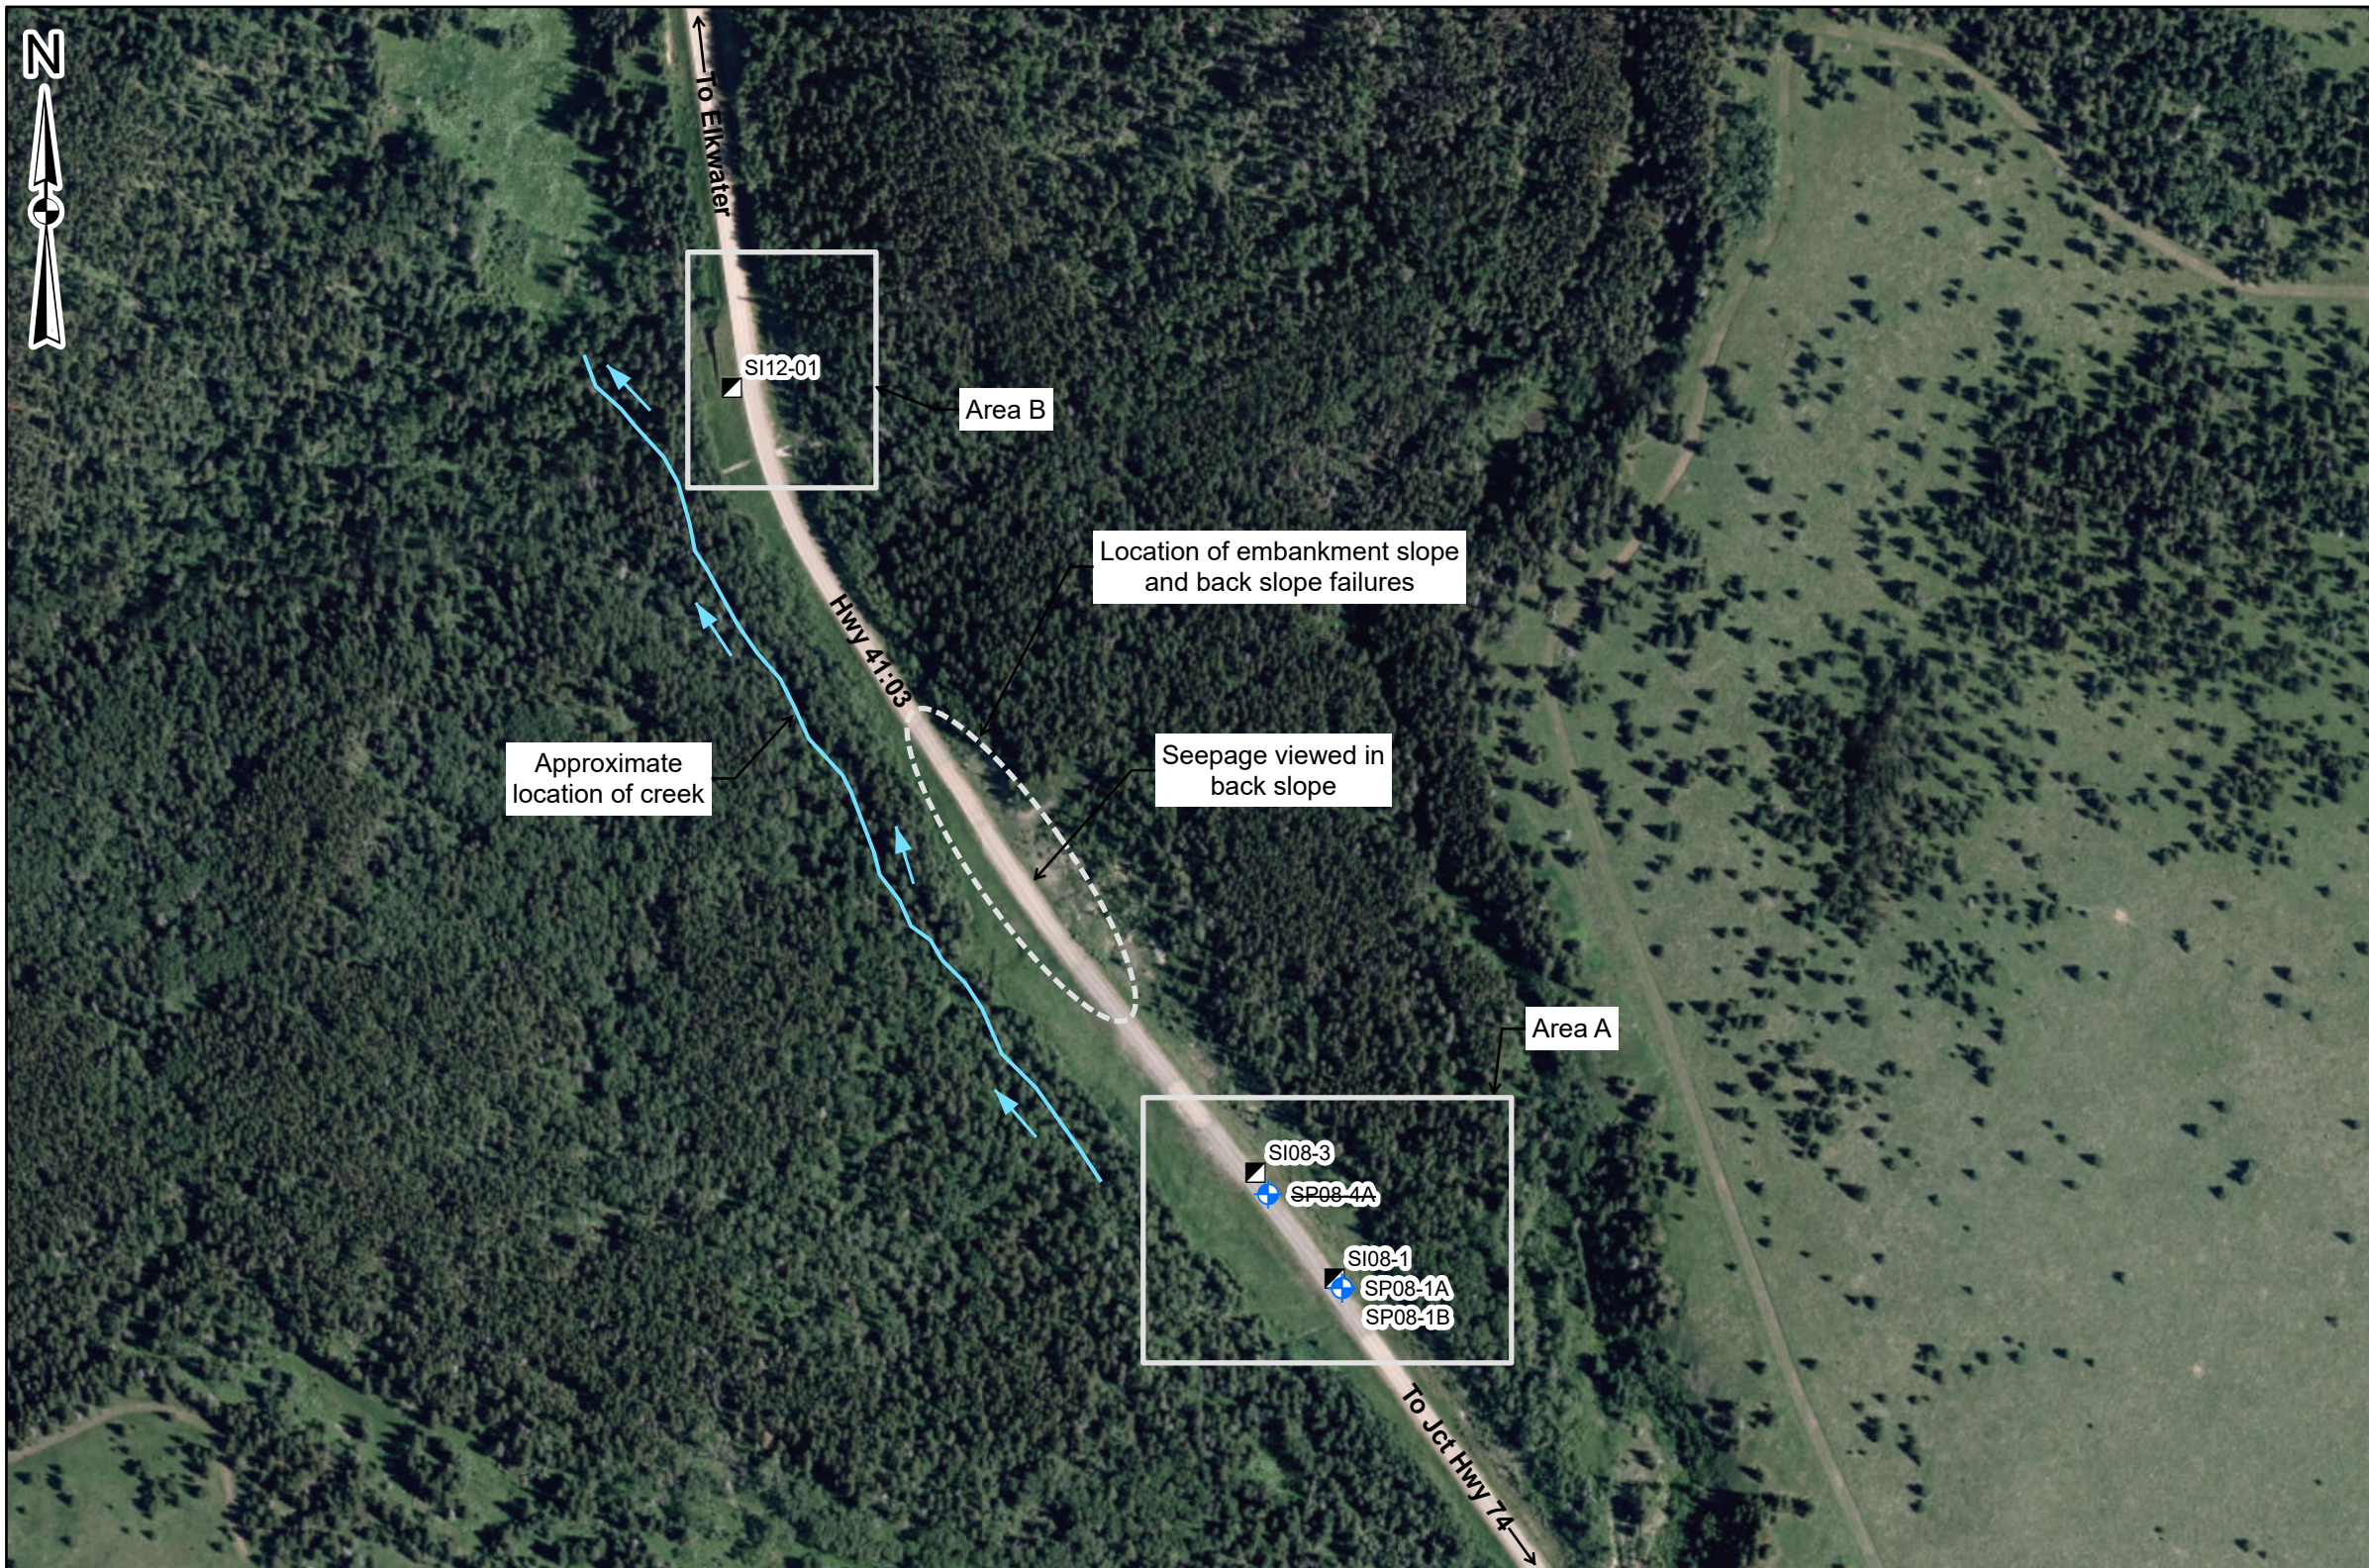
## FIGURE

Three slope inclinometers (SIs) (SI08-1, SI08-3, and SI12-1) and two standpipe piezometers (SPs) (SP08-01A and SP08-01B) were read at the S026 site in the Southern Region on May 16, 2024, by Mr. Bradley Lawson, E.I.T. of Klohn Crippen Berger Ltd. (KCB). These instruments were read as part of the Southern Region Geohazard Risk Management Plan (GRMP). The site is located at Hwy 41:03 km 35.2, approximately 4 km south of the turnoff from Hwy 41:03 to the Town of Elkwater, Alberta. The approximate site coordinates are 5499046 N, 553536 E (UTM Zone 12, NAD 83). A site plan is presented in Figure 1.
