September 2, 2016

Alberta Transportation  
2<sup>nd</sup> Floor, 803 Manning Road NE  
Calgary, Alberta  
T2E 7M8

**CON0017609 Southern Region GRMP - Call-Out Reports**  
**S049 - Hwy 504:02-01 Embankment and Foundation Earth Slide (km 23.917)**

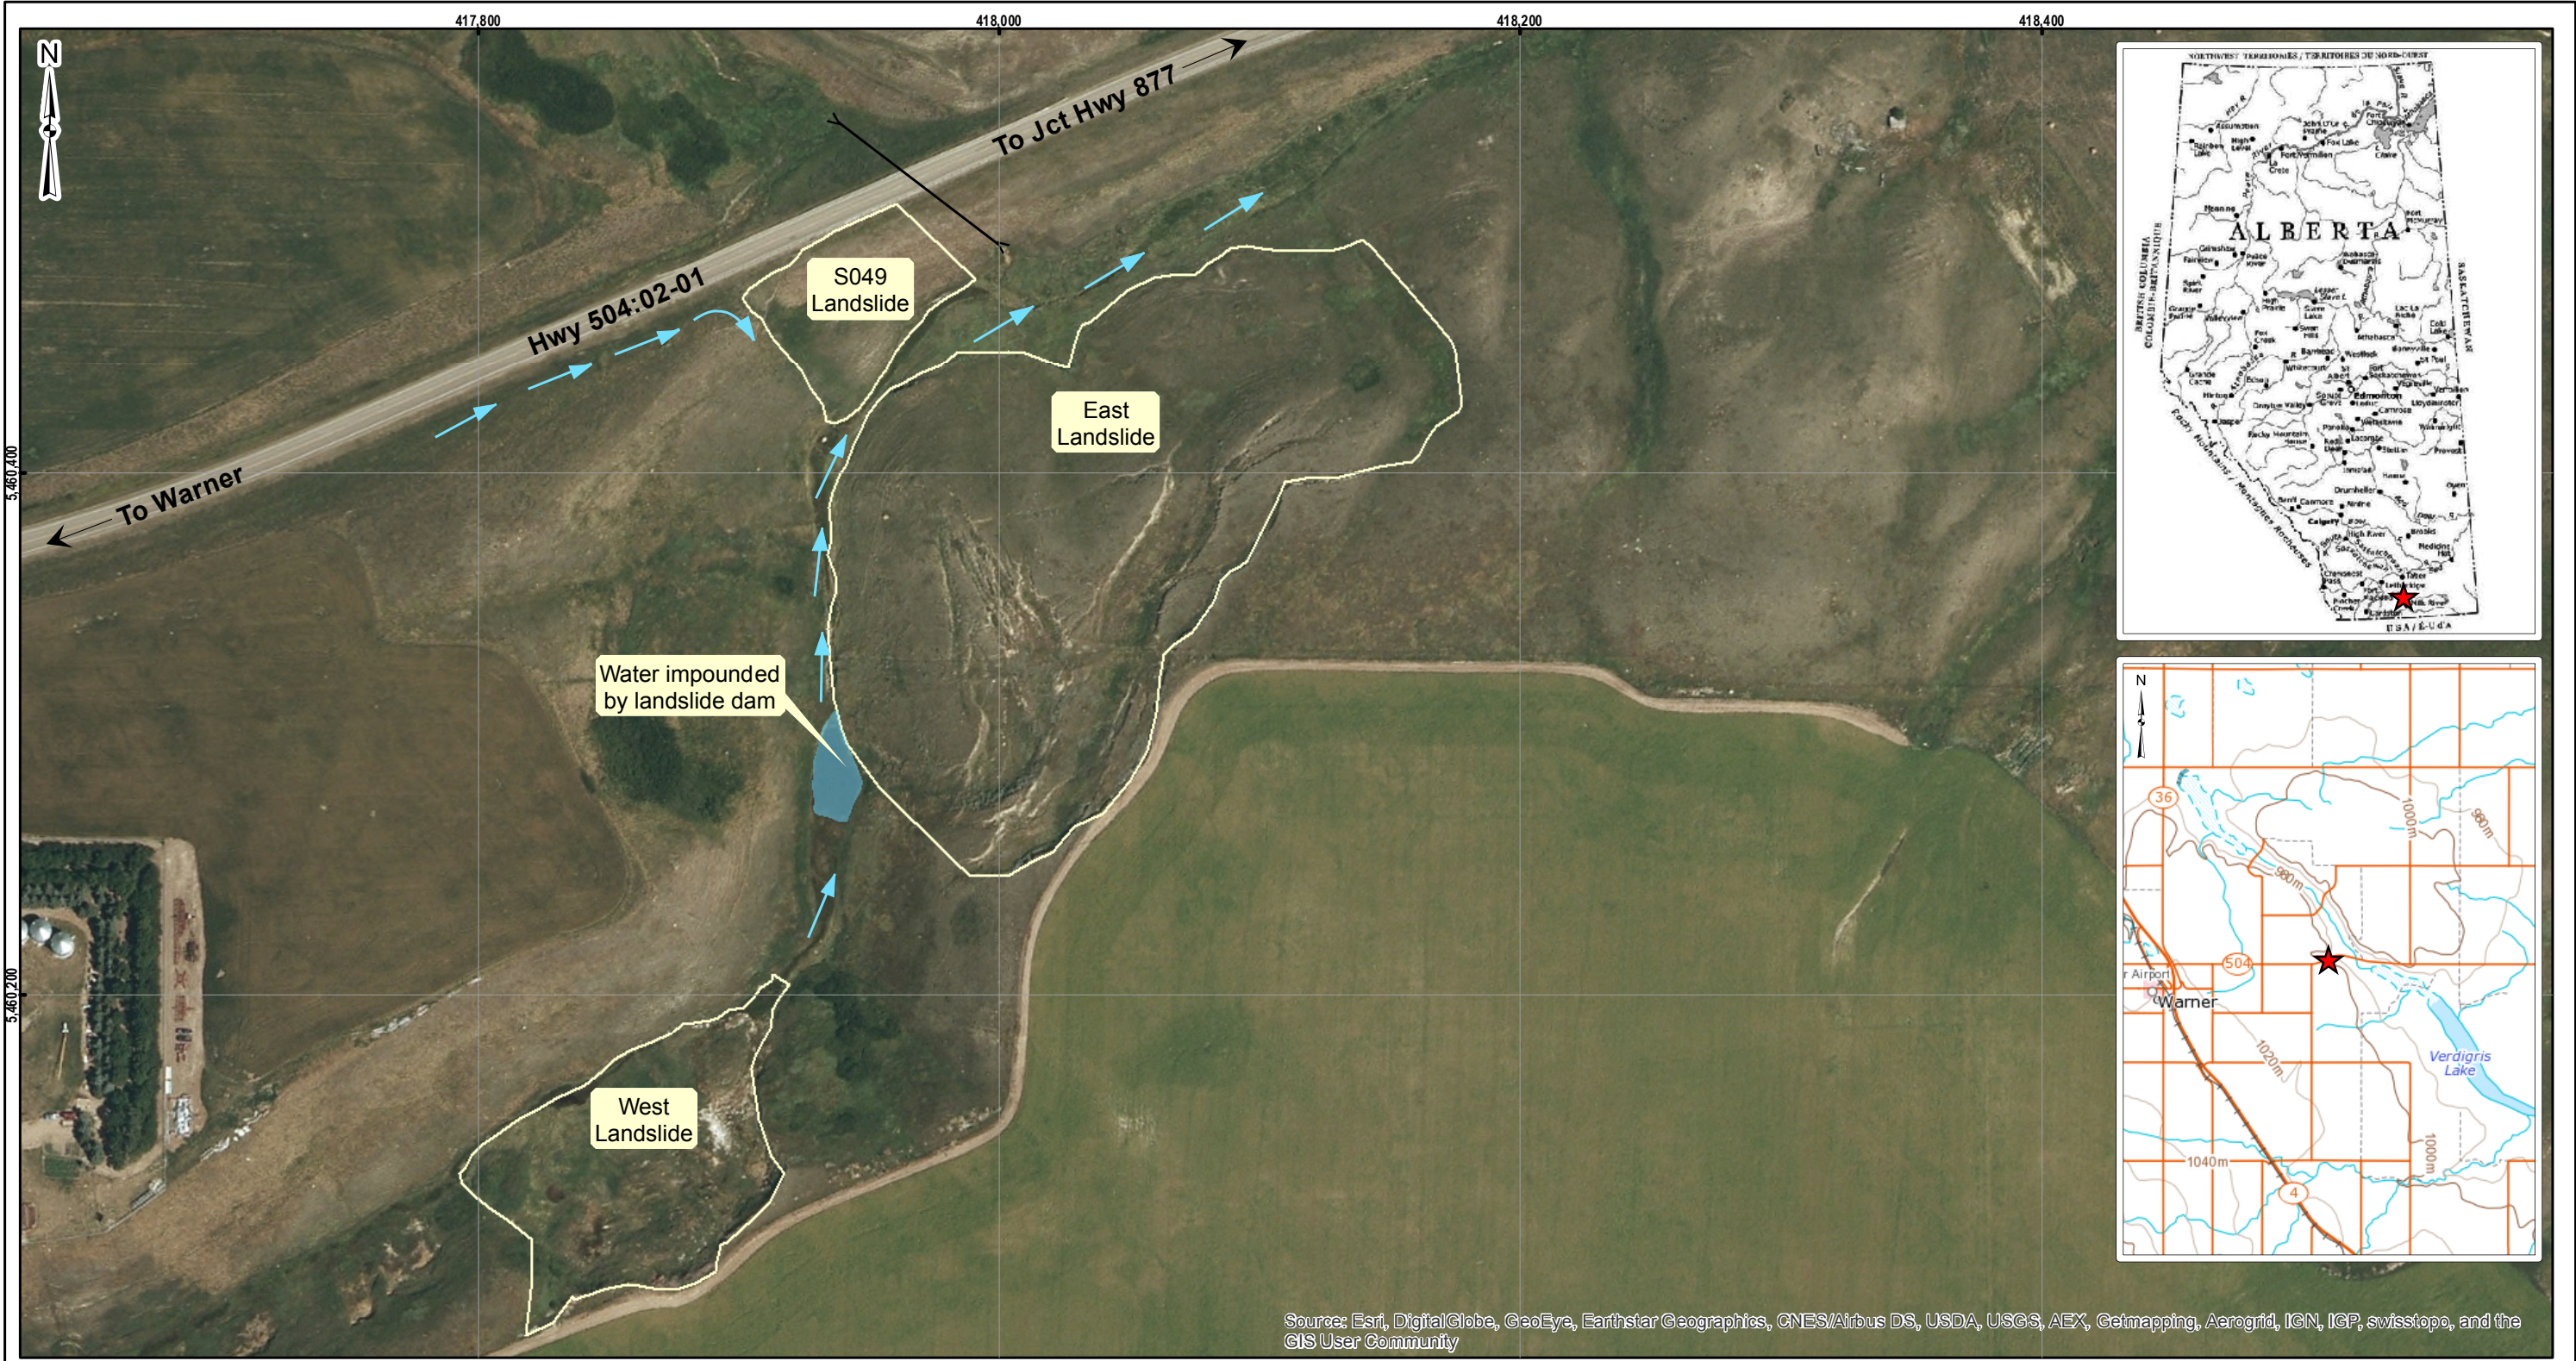
PROJECT SOUTHERN REGION GEOHAZARD RISK MANAGEMENT PROGRAM		
TITLE Call-Out Overview S050 - Embankment Earth Slide and Damaged Culvert Hwy 549:02-01, km 4.831		
SCALE 1:2,500	PROJECT No. A05115A03	FIG No. 1

Figure 1 illustrates the basic arrangement of the various features observed at the site during the June 16th, 2016 site inspection. The following observations were made during the site visit:
