July 14, 2023

**CON0022161 Southern Region GRMP Instrumentation Monitoring
Site S075; H540:02, km 5.720 Pekisko Creek Slides
Section C – 2023 Spring Readings**

2023 S075 Spring Report.docx
A05116A03

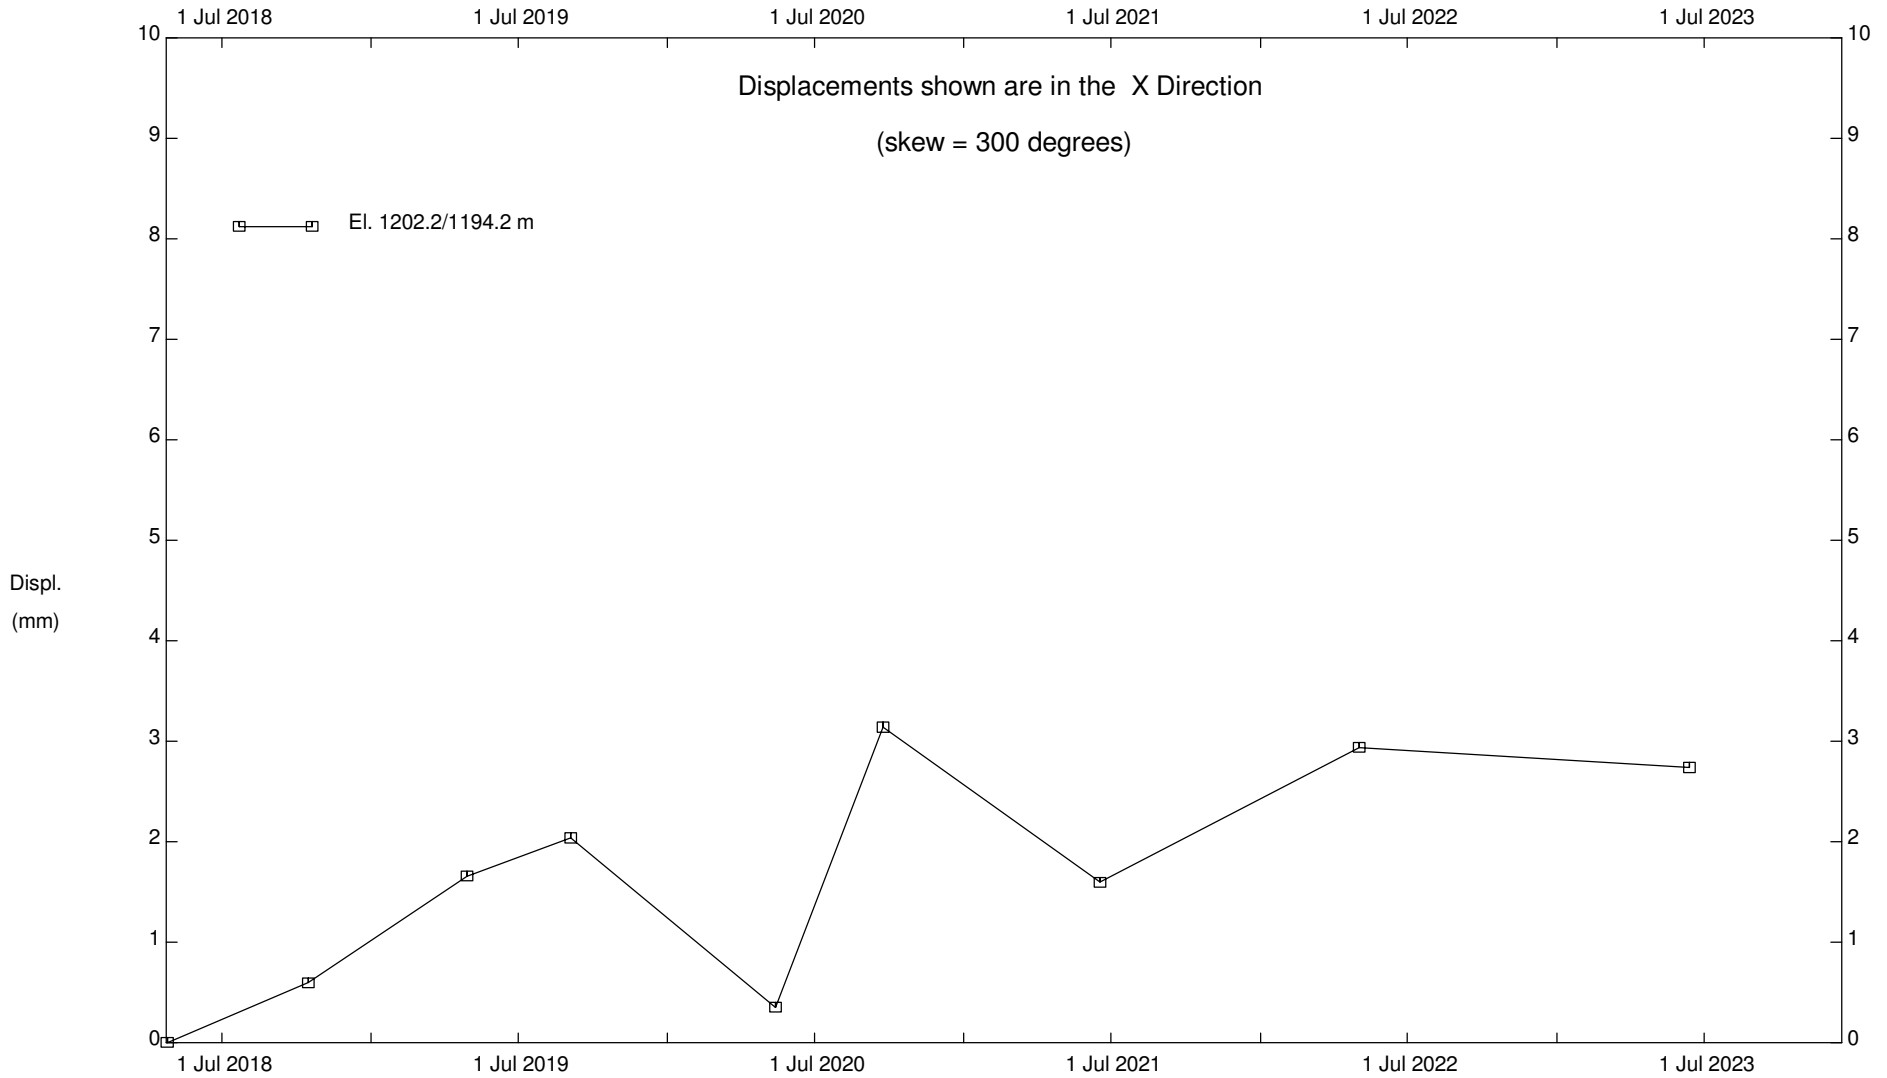
S075; H540:02 - Pekisko Creek, Inclinometer SI17-03
 Alberta Transportation

Prior to SI17-03 being re-initialized in April 2018 and SI17-04 becoming inoperable in 2018, settlement or buckling was observed in both instruments, which could indicate the instruments were poorly grouted with possible grout voids. The interpretation of the SI data is complicated by the potential for settlement or buckling of the SI casing in the poorly grouted casing segment. The instrument was re-initialized to remove possible noise associated with this zone. Overall data quality has improved since the instrument was re-initialized, but settlement or buckling of the casing may still be occurring at this depth. The rate of settlement or buckling has slowed since the first few months following installation and has been generally negligible since the instrument was re-initialized. If the settlement or buckling begins to impact the interpretation of the SI data again, the instrument may need to be re-initialized.
