S13 – SHEEP RIVER SITE

Alberta Transportation
Southern Region Geohazard Assessment
Annual Assessment Report
June 2004

PROJECT: SOUTHERN REGION GEOHAZARD ASSESSMENT

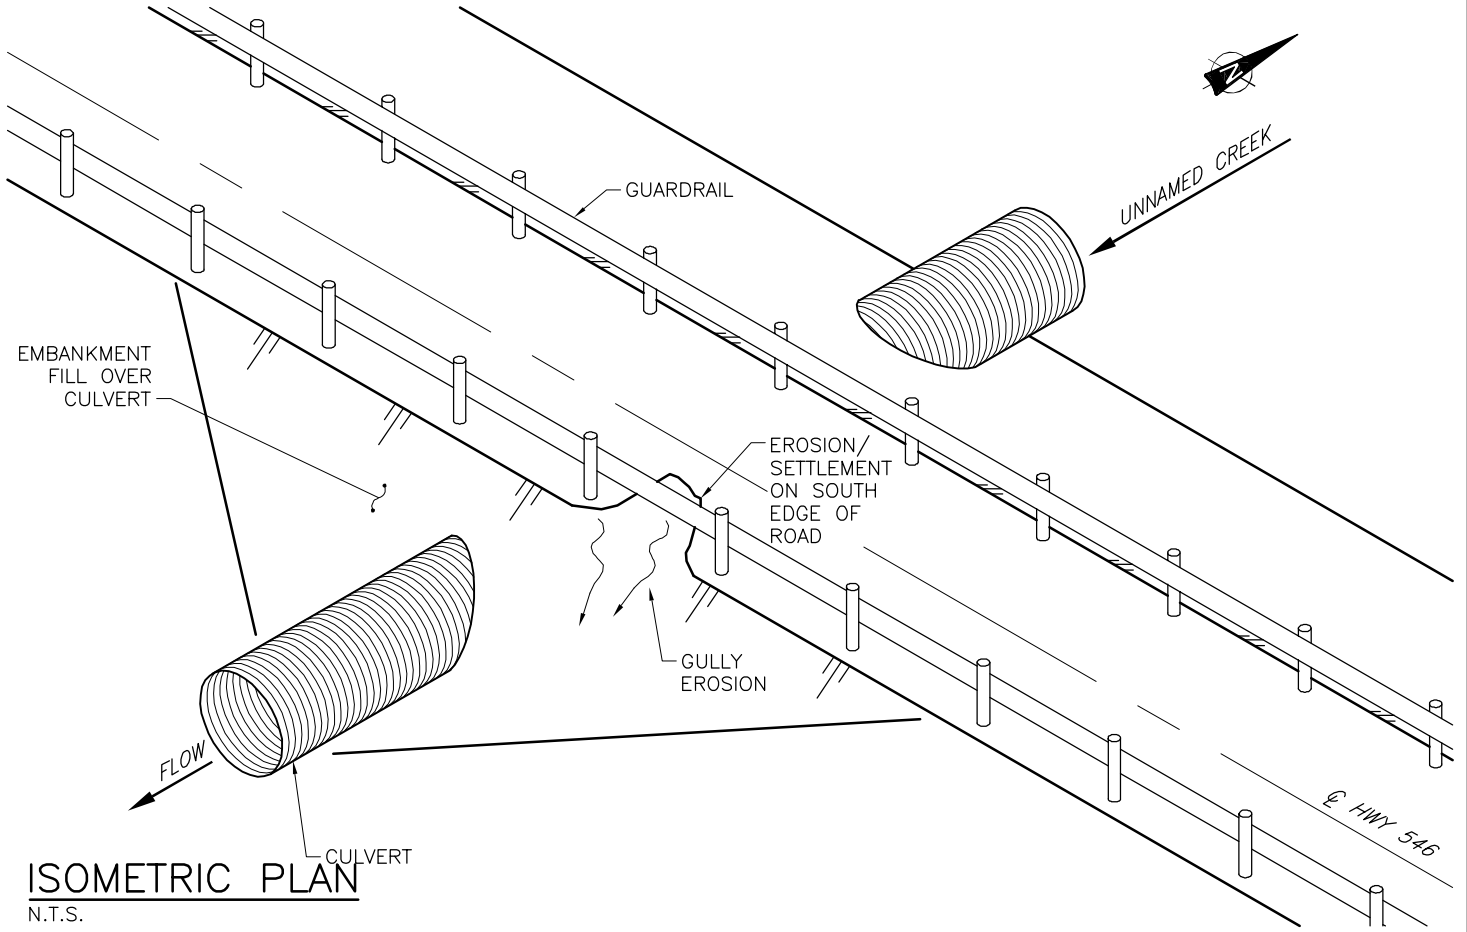
ISOMETRIC PLAN
N.T.S.

- No repair measures have been made to the erosion into the south edge of the road since the 2003 assessment. The previously-noted gully and surface erosion in the fill embankment slope face downslope (south) of the road has been continuing. The gully erosion has retrogressed slightly further (in the order of 0.5 m or less) into the eastbound lane of the road. Photos S13-1 to S13-4 illustrate the site conditions.
- There was a pile of rockfall debris from a rock cut to the east of this site stockpiled on the area downslope (south) of the guardrail on the east side of the creek, as shown in Photo S13-3. AMEC understands that this has been done in previous years prior to disposing of the debris by bulldozing it into the gully downstream of the road.

The gullying on the fill slope below the road should be mitigated by improved control of the runoff from the road surface. AMEC recommends the following to achieve this (see Figure 2-S13 in Appendix S13 for a schematic illustration):
