SITE NUMBER AND NAME: S056-IV West Gorge Creek, west of Turner Valley		HIGHWAY & KM: Sheep River Road	PREVIOUS INSPECTION DATE: N/A	INSPECTION DATE: May 6, 2019
LEGAL DESCRIPTION: 12-36-019-05 W5M	NAD 83 COORDINATES: UTM Northing Easting 11 5614130 671333		RISK ASSESSMENT: PF: 3 CF: 2 TOTAL: 6 (Erosion) PF: 2 CF: 1 TOTAL: 2 (Rockfall)	
MONTHLY AVERAGE DAILY TRAFFIC (MADT): June 2017 360 (west), 300 (east). (Ref. No. 55460220)			CONTRACTOR MAINTENANCE AREA (CMA): 27

NOTES: 1. HORIZONTAL DATUM: NAD83 2. GRID ZONE: UTM Zone 11N 3. IMAGE SOURCE: Bing Maps 2019, Microsoft Corporation.	CLIENT 	PROJECT SOUTHERN REGION GEOHAZARD RISK MANAGEMENT PROGRAM
		TITLE Site Plan West Gorge Creek Site IV Sheep River Road
SCALE 1:1,000	PROJECT No. A05115A03	FIG No. 1

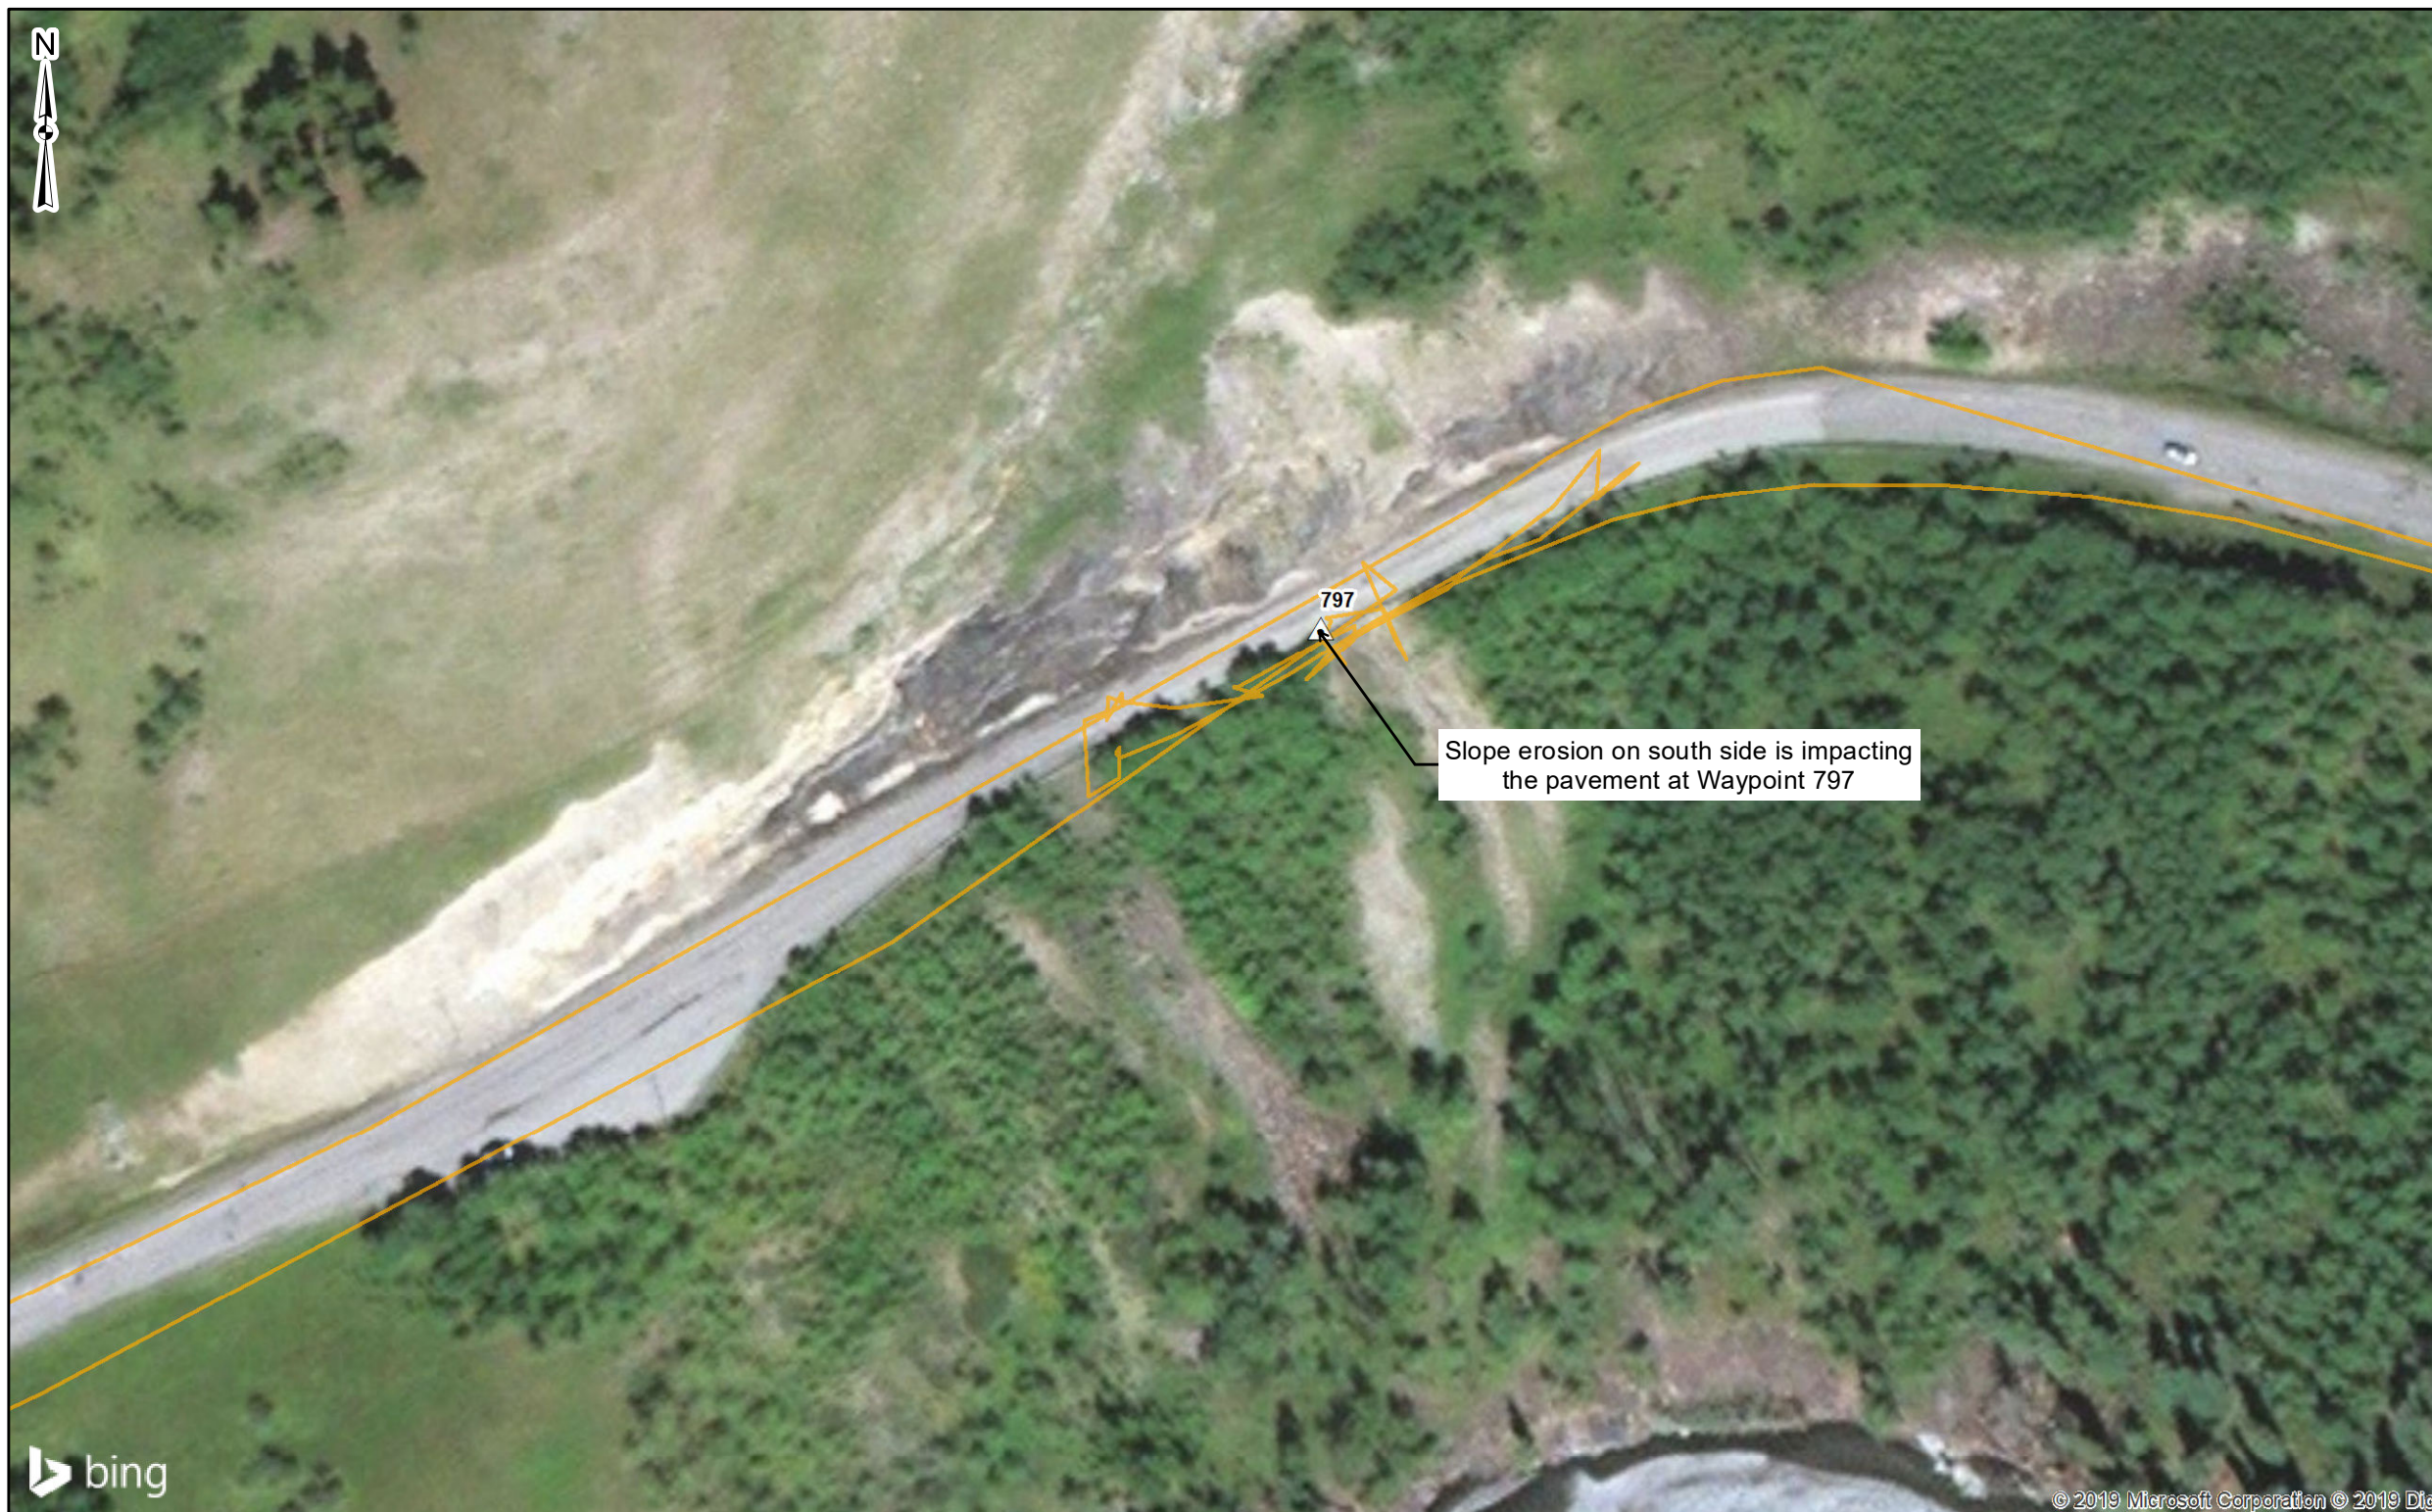
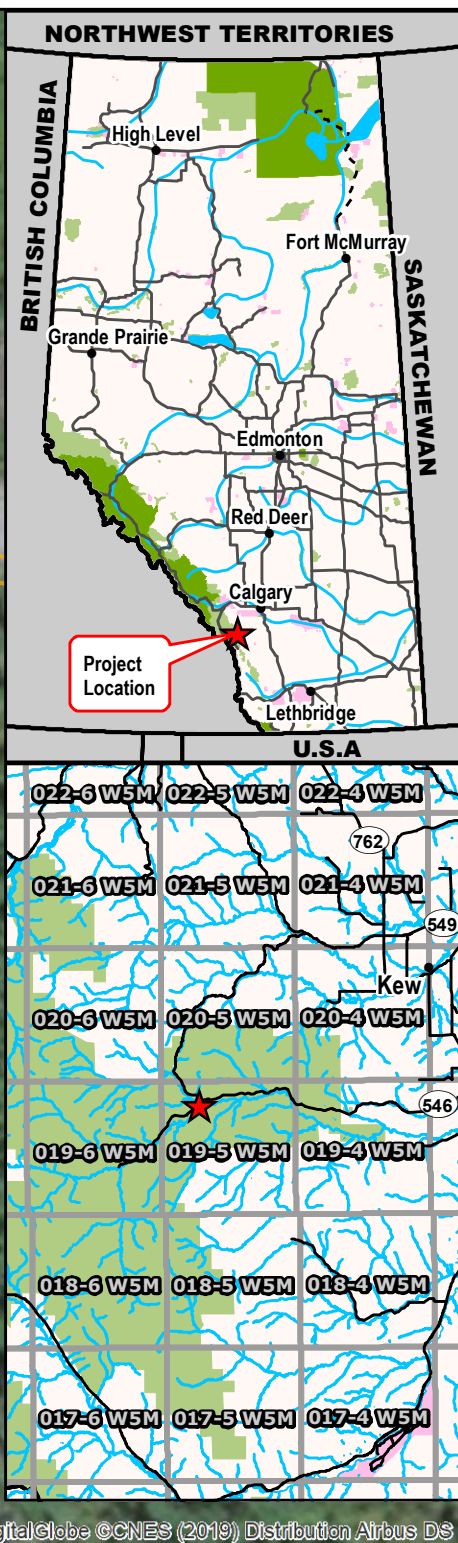
SUMMARY OF SITE INSTRUMENTATION: None LAST READING DATE: N/A	INSPECTED BY: Chris Gräpel (KCB) Chris Morgan (KCB) Alex Frotten (AT) Roger Skirrow (AT) Nicolas Ropchan (AT) Maury Siddons (AT)
PRIMARY SITE ISSUE: Rock slope adjacent to the highway with ongoing sloughing. Rocks from the slope are falling onto the road.	
APPROXIMATE DIMENSIONS: Rock face is approximately 120 m long. Slope erosion south of the highway has undermined the safety barrier and has reached the pavement edge.	
DATE OF ANY REMEDIAL ACTION: N/A

ITEM	CONDITION EXISTS		DESCRIPTION AND LOCATION	NOTICABLE CHANGE FROM LAST INSPECTION	
	YES	NO		YES	NO
Pavement Distress	X		Damage to pavement observed due to rockfalls.		
Slope Movement		X			
Erosion	X		Surface water runoff leading to slope erosion on southern side of highway.		
Seepage		X	None observed.		
Culvert Distress		X			
COMMENTS					
First visit to the site. Site will be monitored moving forward.					
Rock slope on north side of highway consists of folded and fractured sandstone and conglomerate with claystone layers. The toe ditch is shallow and rocks are falling onto the highway. A culvert under the road is present at the east end and is plugged with a rock.					
Surface runoff is eroding the slope south of the highway and erosion has reached the pavement edge.

- Clean out the toe ditch and unplug the culvert beneath the road to minimize runoff erosion into the existing erosion site.

- Rock slope analysis to evaluate rockfall potential and routes;
- Scaling of portions of the rock slope where the rock slope is directly adjacent to the road to create a rock fall ditch; and
- Installation of rockfall fence partway up the rock slope to catch rocks with the potential to bounce onto the roadway.
