SOUTHERN REGION GRMP SITE INSPECTION FORM

SITE NUMBER AND NAME:	HIGHWAY & KM:	PREVIOUS	INSPECTION DATE:	
S045-I West Fisher Creek	549:02, 10.704	INSPECTION DATE:	June 8, 2020	
		May 6, 2019		
LEGAL DESCRIPTION:	NAD 83 COORDINATES:	RISK ASSESMENT:		
16-08-021-03 W5M	UTM Northing Easting	PF: 11 CF: 4 T	OTAL: 44	
	11 5626463 683084			
AVERAGE ANNUAL DAILY TR	RAFFIC (AADT):	CONTRACTOR MAINTENANCE AREA (CMA):		
760 (east), (Ref. No. 65170)		27

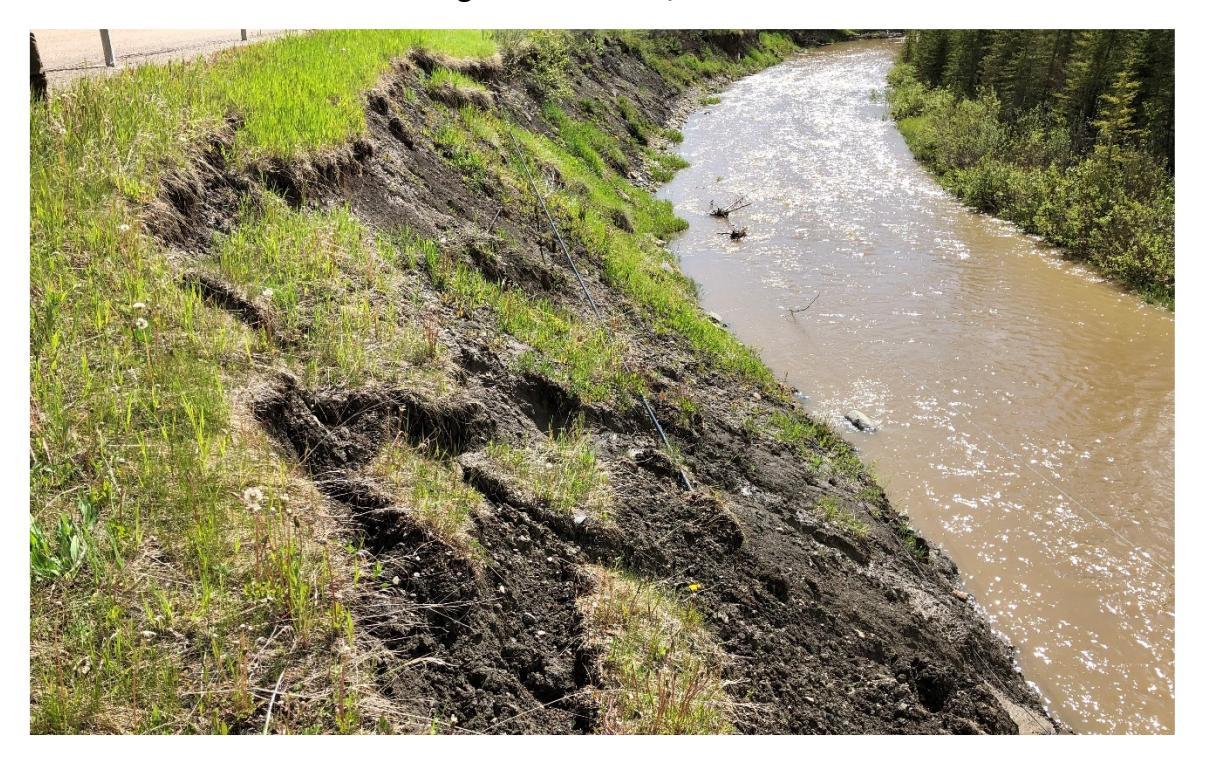
Erosion and sloughing of the slope are undermining the fence. Recently displaced blocks of grass and soil were observed. The equivalent of thirteen fence posts were hanging during 2020 site visit (same number as last year).

Photo 4 Displaced grass and soil due to surface runoff and ongoing bank erosion from Fisher Creek. Photo taken facing east on June 8, 2020.
