SITE NUMBER AND NAME: <b>S045-II Threepoint Creek</b>		HIGHWAY & KM: 549:02, 12.315	PREVIOUS INSPECTION DATE: May 6, 2019	INSPECTION DATE: <b>June 8, 2020</b>
LEGAL DESCRIPTION: 02-08-021-03 W5M	NAD 83 COORDINATES: UTM Northing Easting 11 5626611 684647		RISK ASSESSMENT: PF: 7 CF: 4 TOTAL: 28	
AVERAGE ANNUAL DAILY TRAFFIC (AADT): 760 (east), (Ref. No. 65170)			CONTRACTOR MAINTENANCE AREA (CMA): 27

NOTES: 1. HORIZONTAL DATUM: NAD83 2. GRID ZONE: UTM Zone 11N 3. IMAGE SOURCE: World Imagery from ESRI ArcGIS Online. Source date January 2015	CLIENT 	PROJECT SOUTHERN REGION GEOHAZARD RISK MANAGEMENT PROGRAM
		TITLE Site Plan S045-II - Threepoint Creek H549:02, km 12.315
SCALE 1:2,000	PROJECT No. A05115A03	FIG No. 1

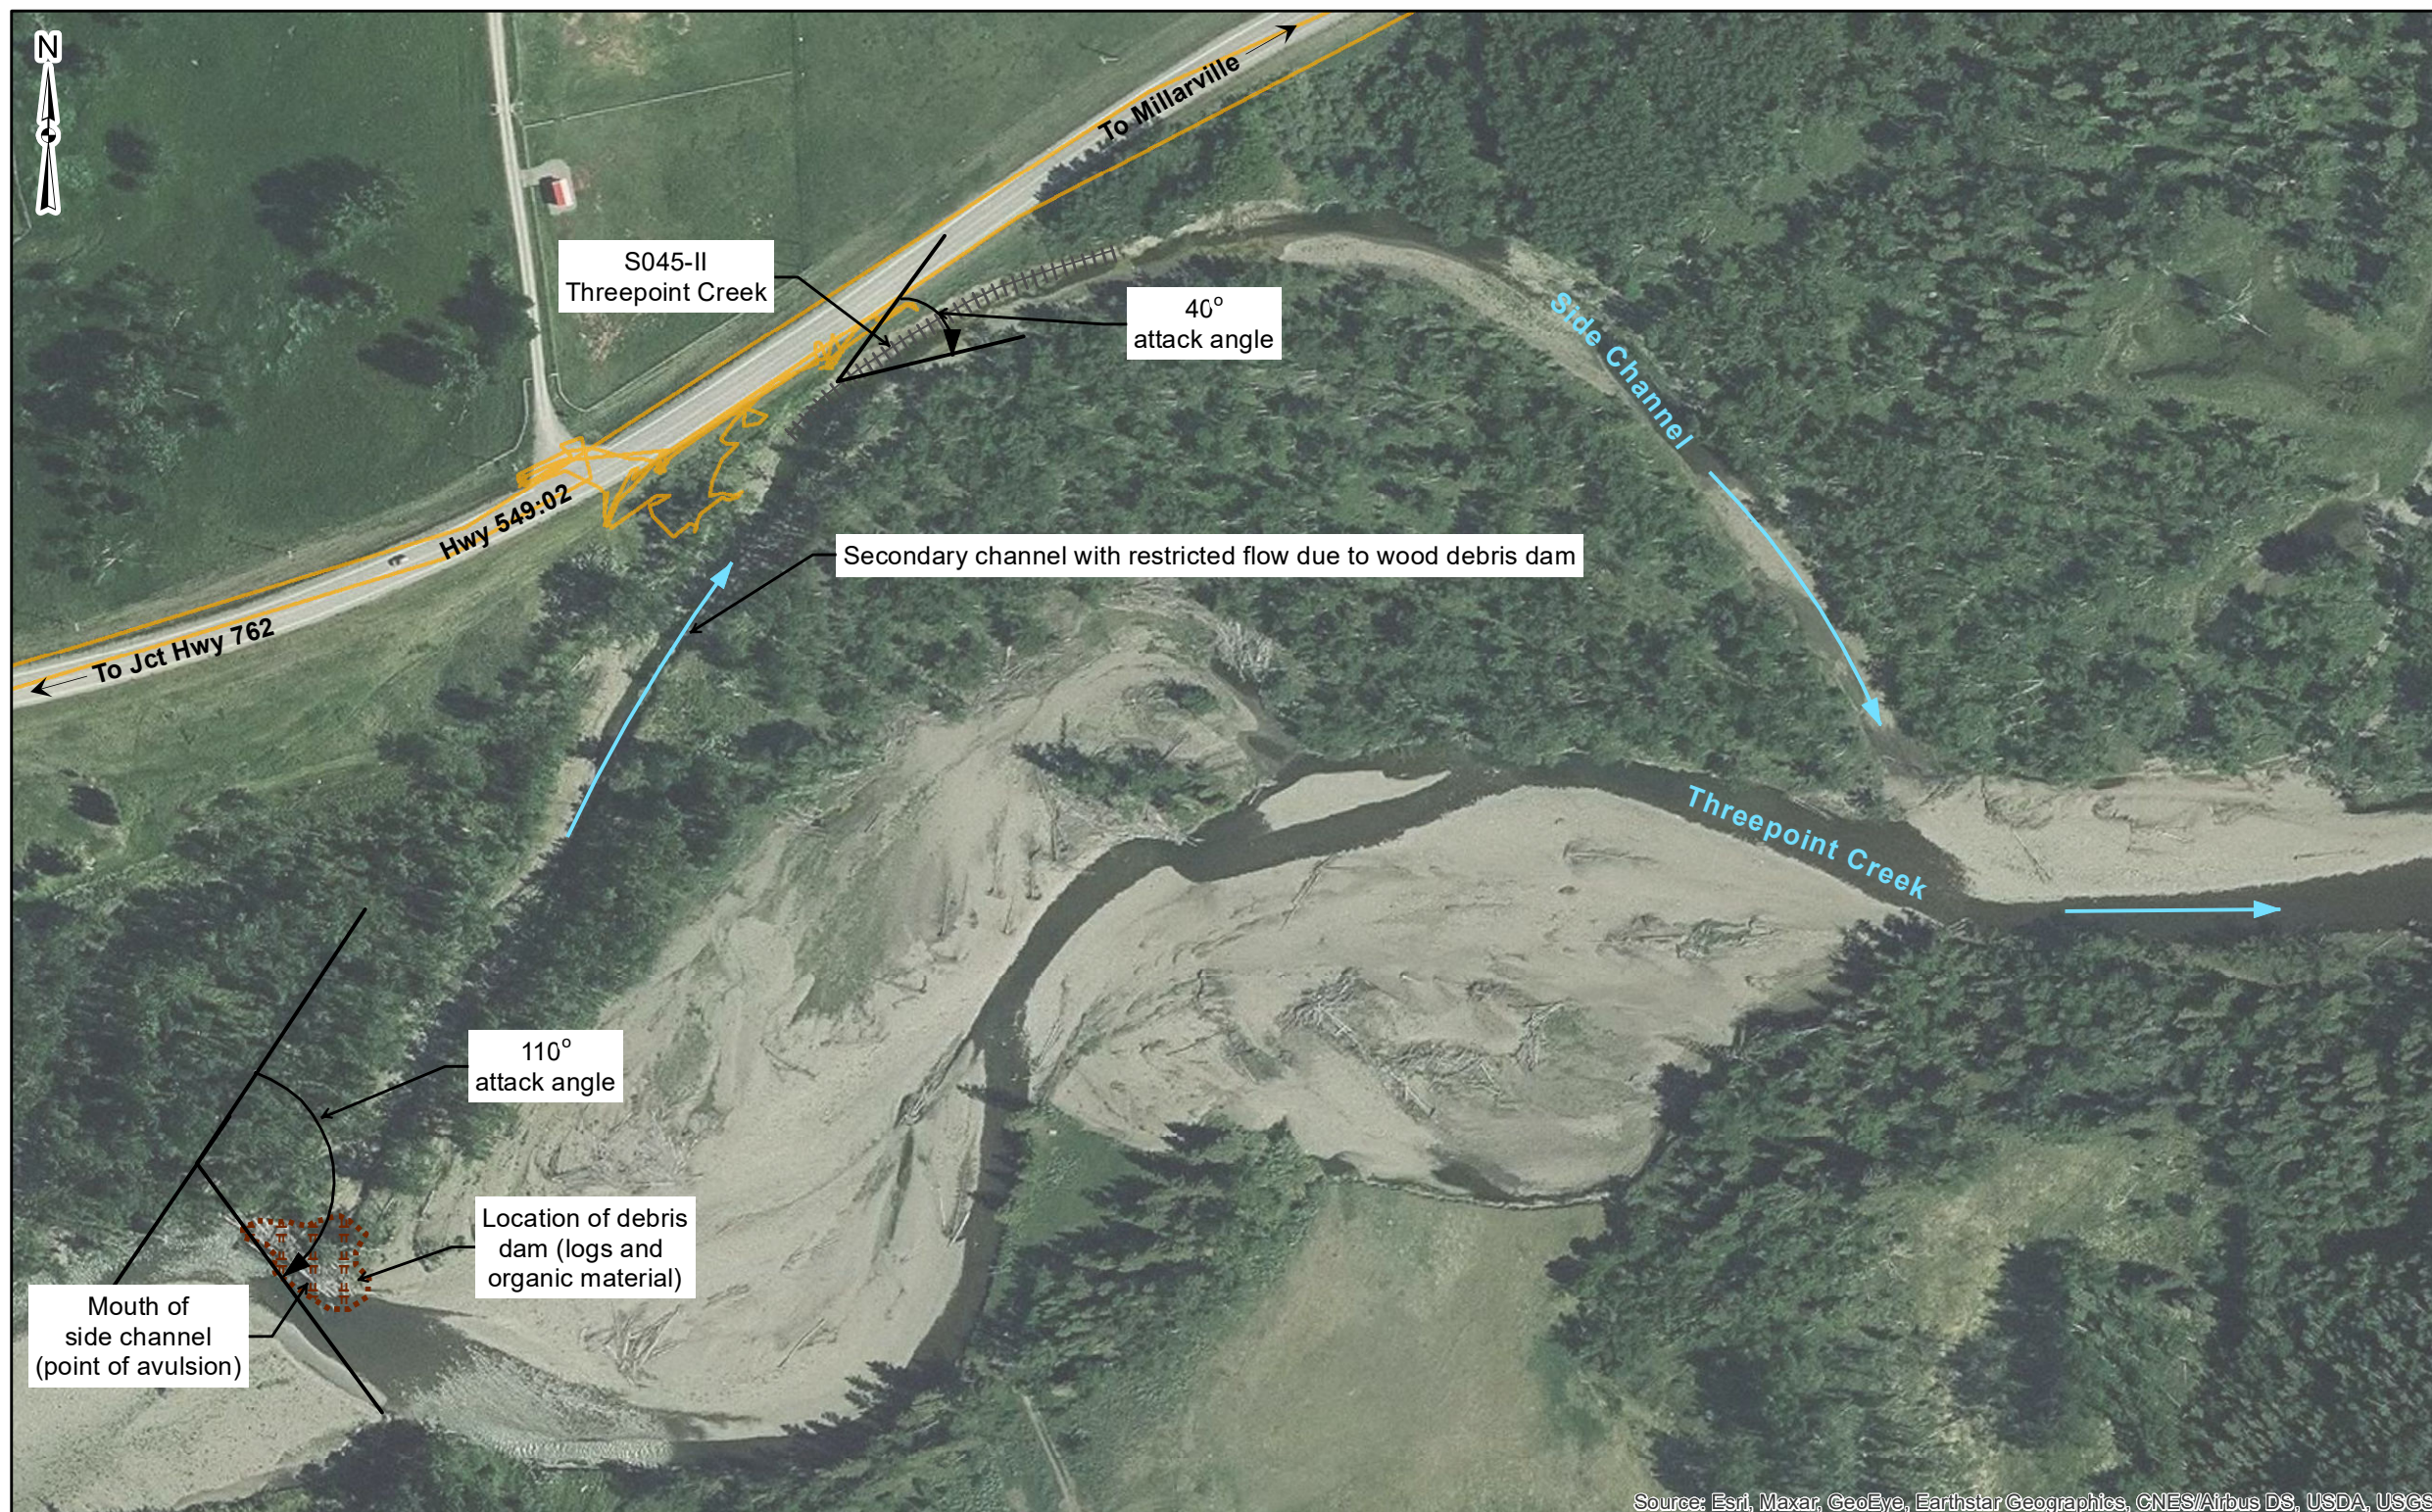
COMMENTS
The side channel adjacent to Site II was blocked by a wood debris dam deposited in June 2013. The debris dam restricts flow in the side channel, however the 2020 site visit observed an increased volume of channel flow when compared to 2019, suggesting that the debris dam is starting to decay and break down.
2020 observations also noted that the creek has started outflanking the debris dam on the upstream side.
No change in condition of the erosion scarp was observed in 2020. Increasing flow in the side channel may lead to reactivation of earth slope toe erosion.
The fence at the top of the eroded slope has been undermined and 5 posts have fallen over.
An oil pipeline is present, located between highway and the side channel and running parallel to the highway.
A tension crack appeared to be forming in the embankment side slope, approximately 1.8 m upslope of the existing bank erosion crest.

Repair design is underway to protect the bank from further erosion, that will likely include bank reconstruction and riprap placement. In the short-term, HTCB should be installed to minimize potential for motorists going over the steep erosion scarp.
