November 29, 2024

**CON0022161 Southern Region GRMP Instrumentation Monitoring
Site S012; H742:02, km 4.319 Spray Lakes Road
Section C – 2024 Fall Readings**

TITLE
Site Plan
S012 - Spray Lakes Road
Hwy 742:02, km 4.319

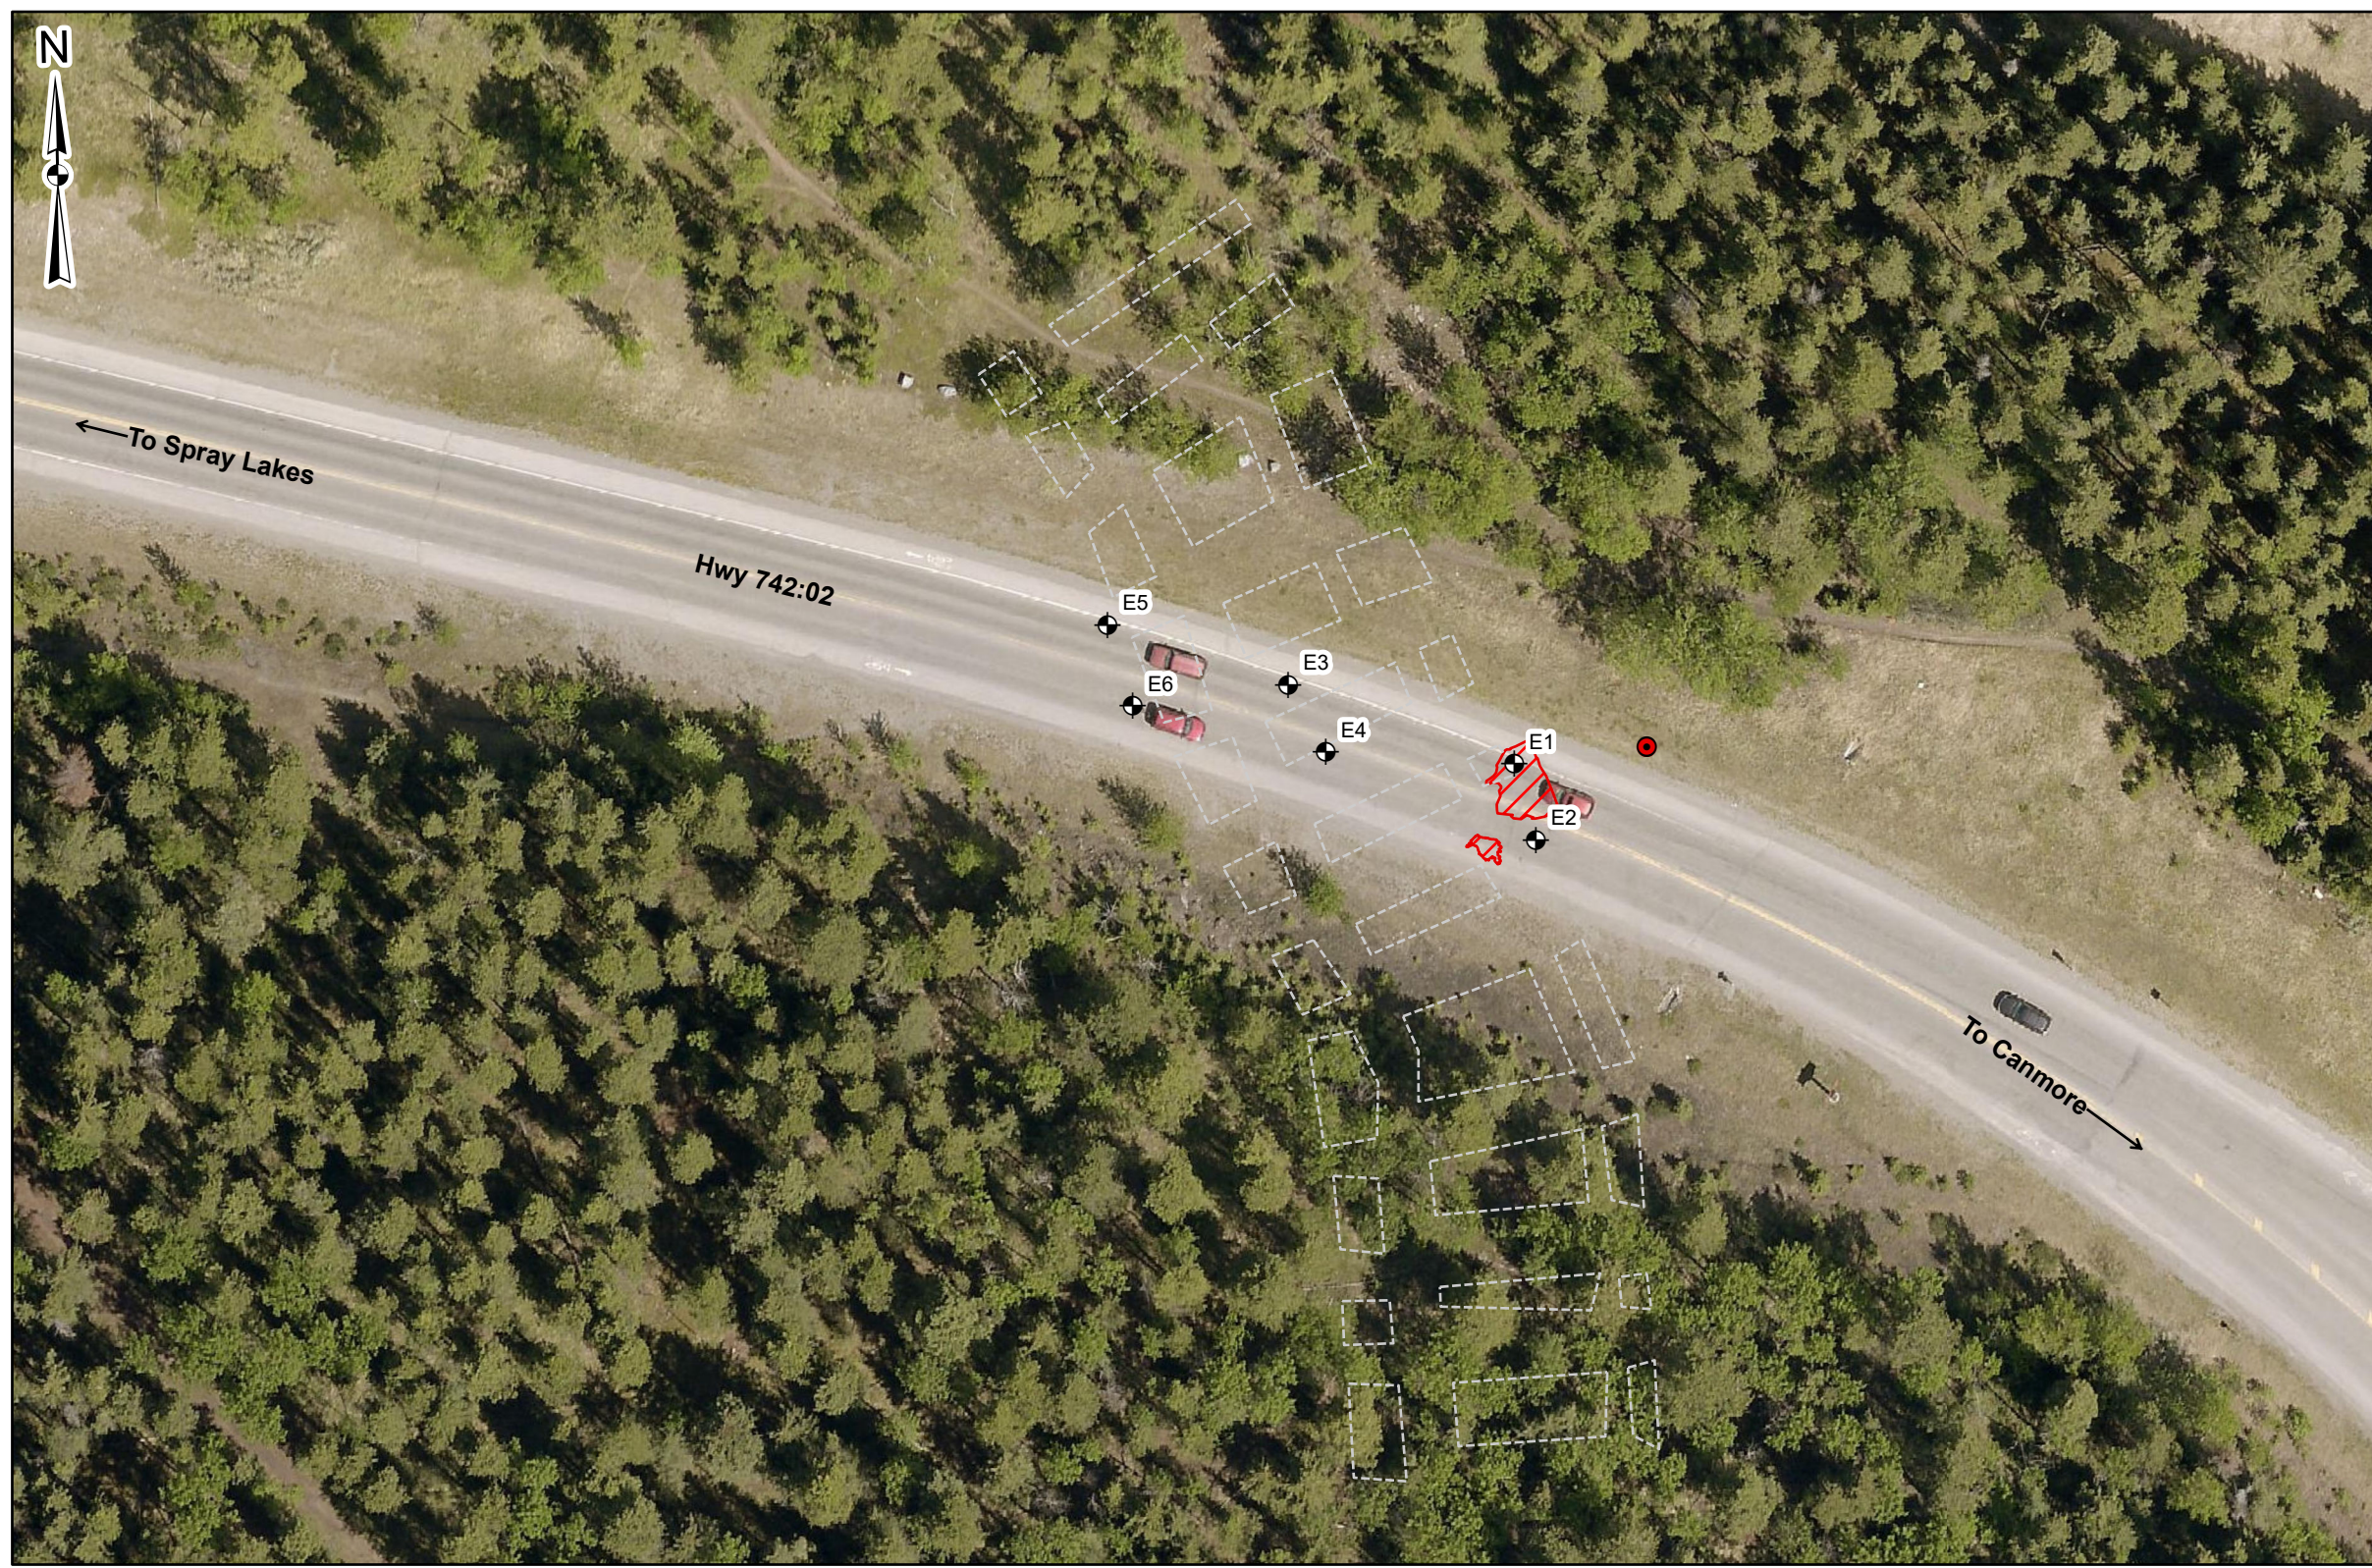
SCALE 1:600 PROJECT No. A05116A03 FIG No. 1

Six vibrating-wire-inline (VWI) extensometers (E1 through E6) consisting of twenty-four individual instruments were read at the S012 site in the Southern Region on September 16, 2024, by Mr. Bradley Lawson, E.I.T. of Klohn Crippen Berger Ltd. (KCB). These instruments were read as part of the Southern Region Geohazard Risk Management Program (GRMP). The S012 site is located on Hwy 742:02, km 4.319 within the Town of Canmore limits and approximately 0.5 km northwest of the Spray Lakes Road and Three Sisters Parkway Junction. The approximate site coordinates are 5659724 N, 614296 E (UTM Zone 11, NAD 83). A site plan is presented in Figure 1.
