November 29, 2024

**CON0022161 Southern Region GRMP Instrumentation Monitoring
Site S008; H762:02, km 2.125 Fisher Creek Pile Wall
Section C – 2024 Fall Readings**

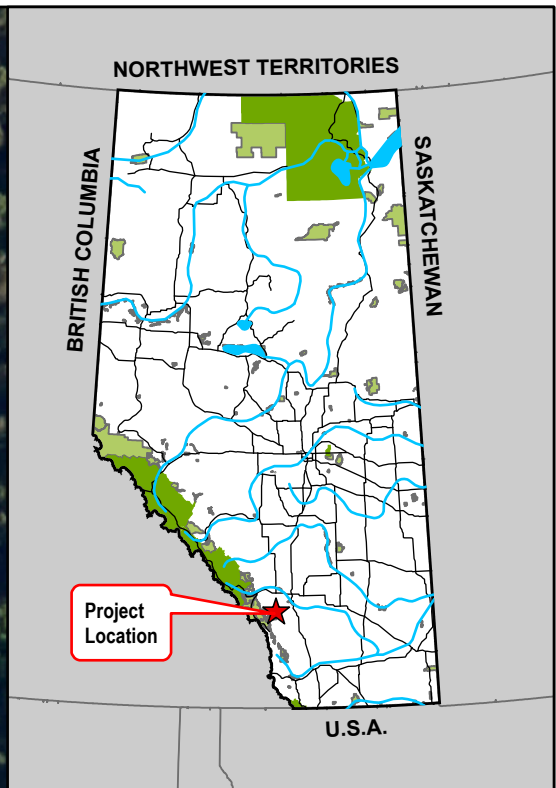
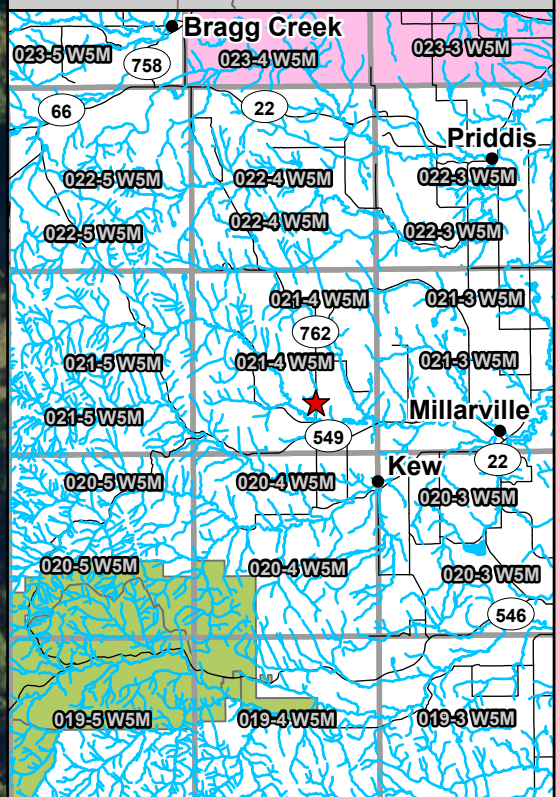
PROJECT SOUTHERN REGION GEOHAZARD RISK MANAGEMENT PROGRAM		
TITLE Site Plan S008 - Fisher Creek Pile Wall Hwy 762:02, km 2.125		
SCALE 1:1,500	PROJECT No. A05116A03	FIG No. 1

- July 2020 – new pavement cracking and an area of settlement (i.e., a dip) were observed in the east (northbound) lane, approximately 24 m north of the existing pile wall.

- July 2021 – the severity of the pavement cracking had increased since the July 2020 inspection. The length of the pavement crack was approximately 11 m.

- July 2022 – the severity of the pavement cracking has continued to increase since the July 2021 inspection. The length of the pavement cracking had increased to approximately 16 m. The pavement cracking was within 0.4 m of the highway centerline and settlement of up to 50 mm was observed in the west (southbound) lane.

- June 2023 - the severity of the pavement cracking has continued to increase since the July 2022 inspection to the north of the pile wall.
- May 2024 - the severity of the pavement cracking has continued to increase since the May 2023 inspection to the north of the pile wall.

KCB recommends that a borehole be drilled approximately 24 m north of the existing pile wall where pavement distress is observed. A SI should then be installed in the borehole to monitor movement at this location. A proposal for this work was issued in December 2022 and reissued in July 2024. Drilling is expected to be completed in January 2025. KCB is updating the proposal to include design and tendering services to remediate the area north of the pile wall.
