September 21, 2022

**CON0022161 Southern Region GRMP Instrumentation Monitoring  
Site S036; H800:02, km 9.05 Belly River  
Section C – 2022 Spring Readings**

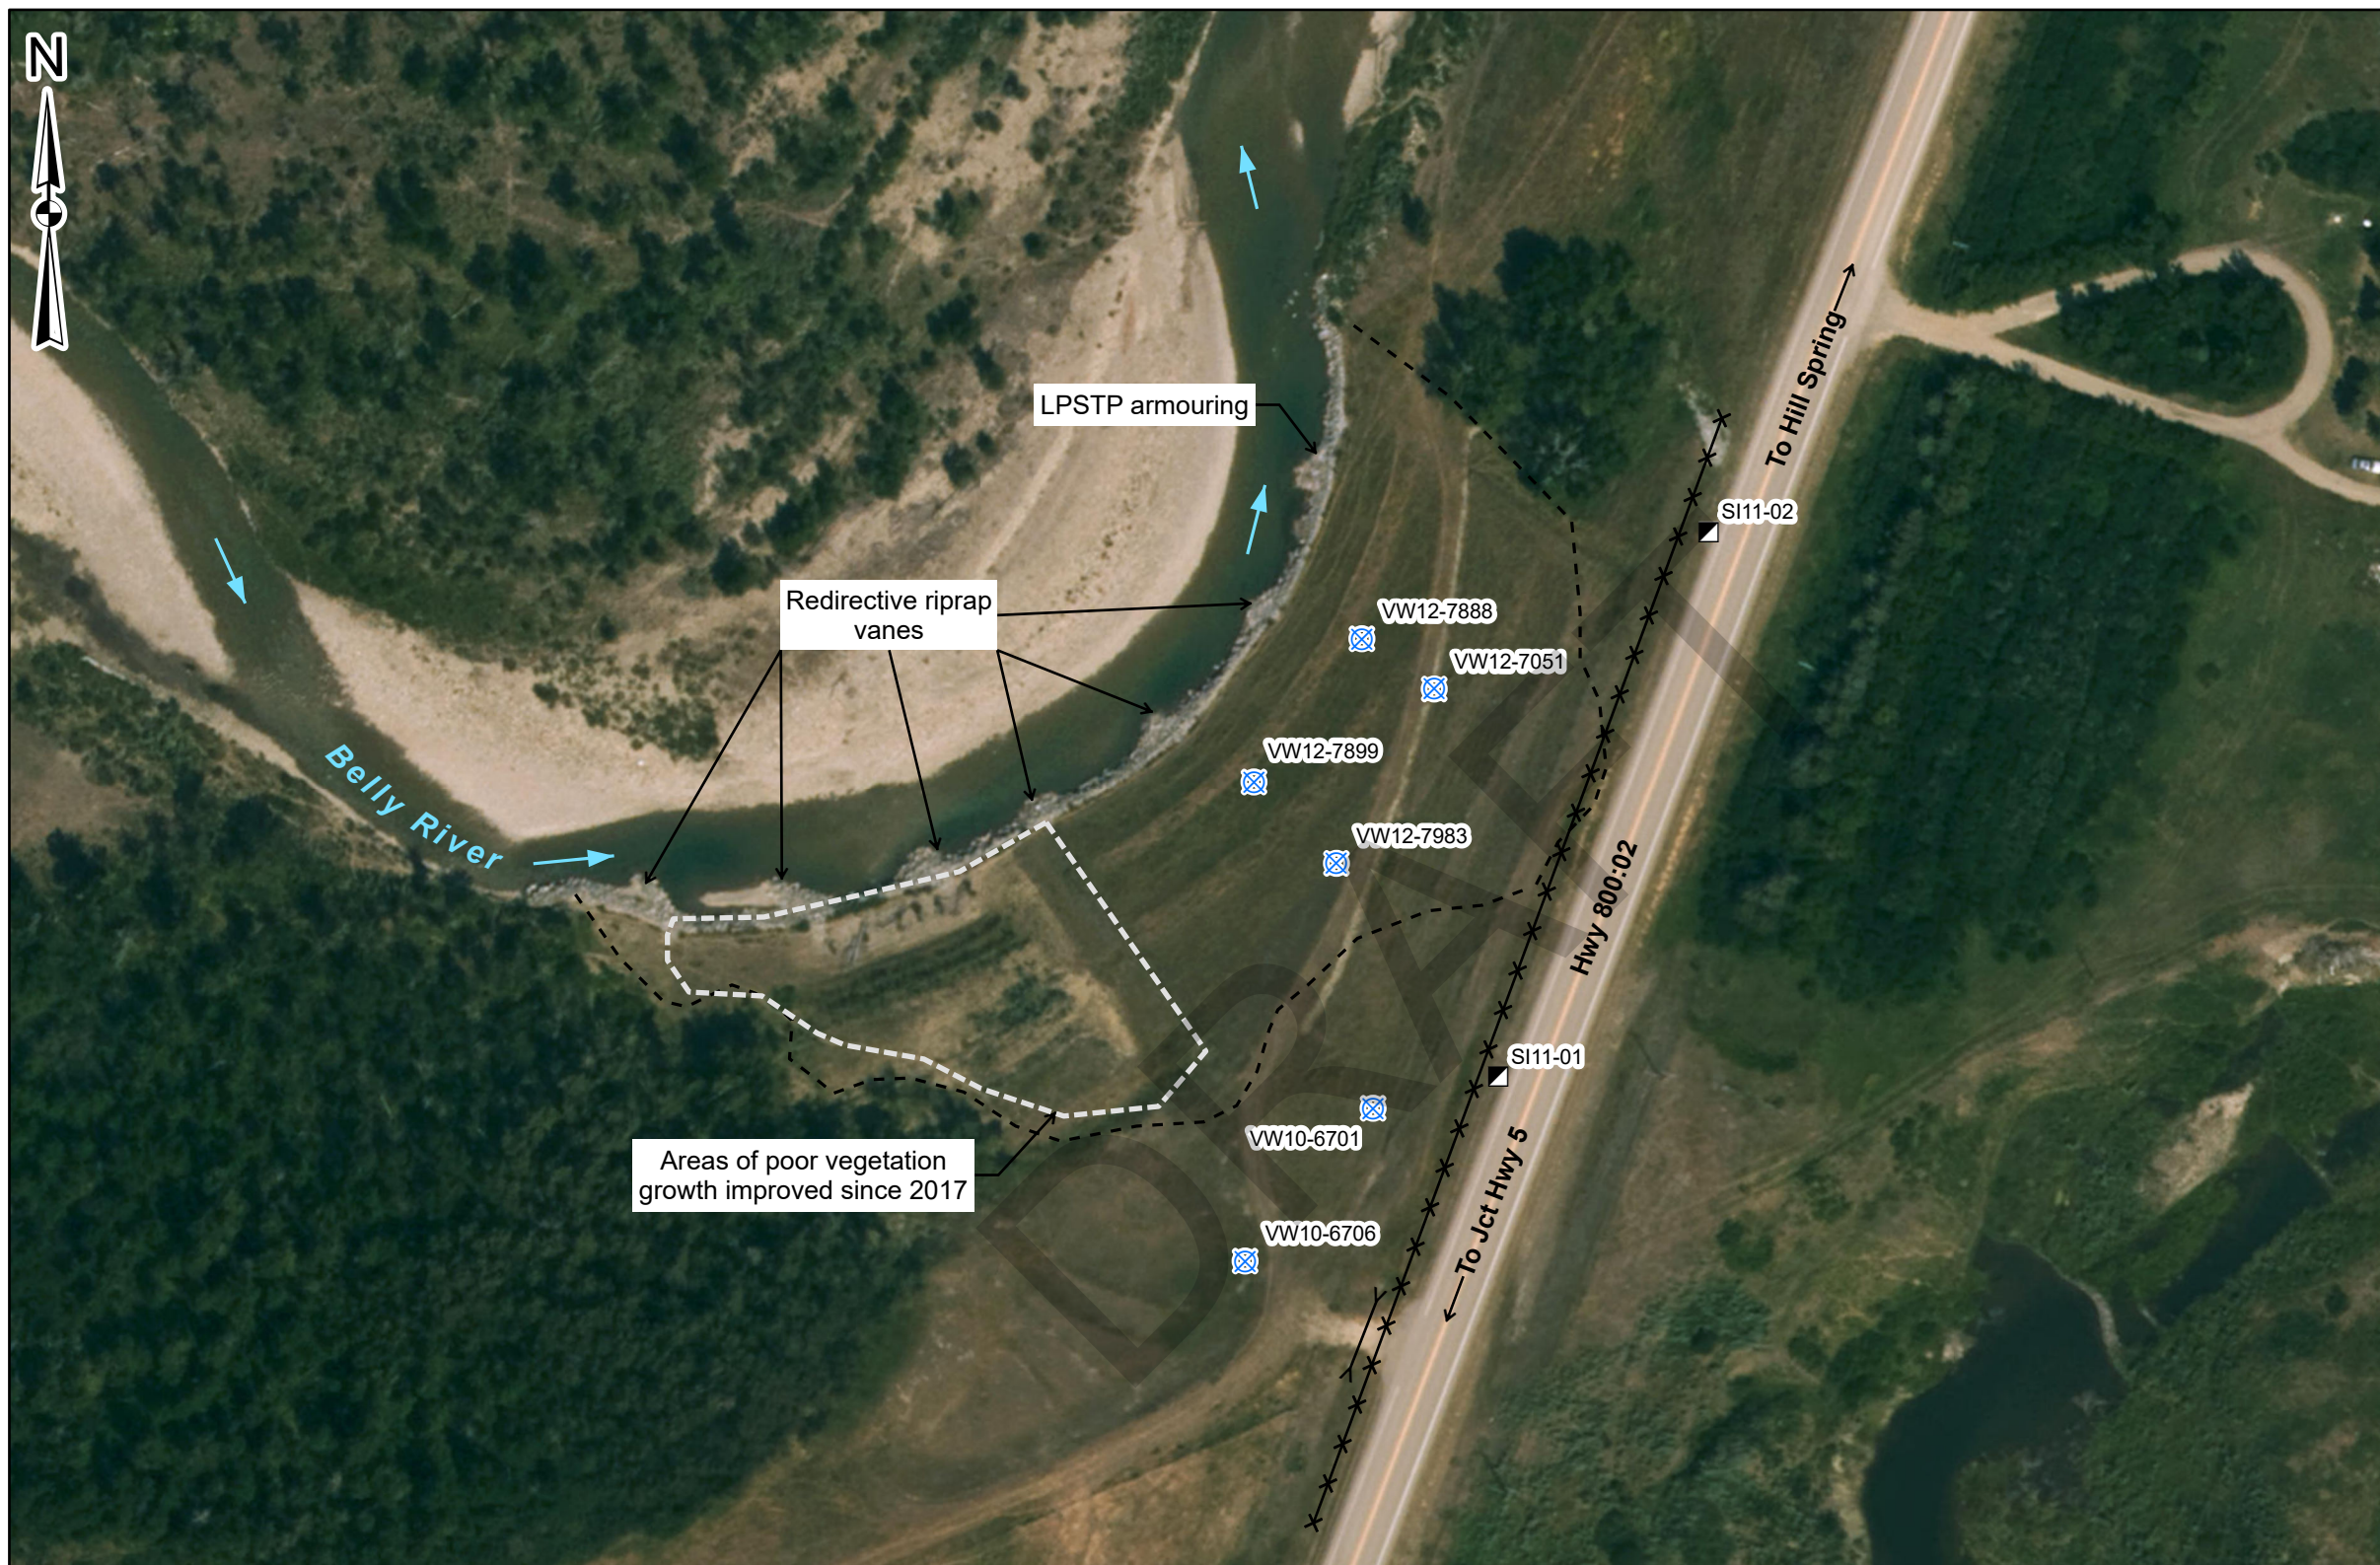
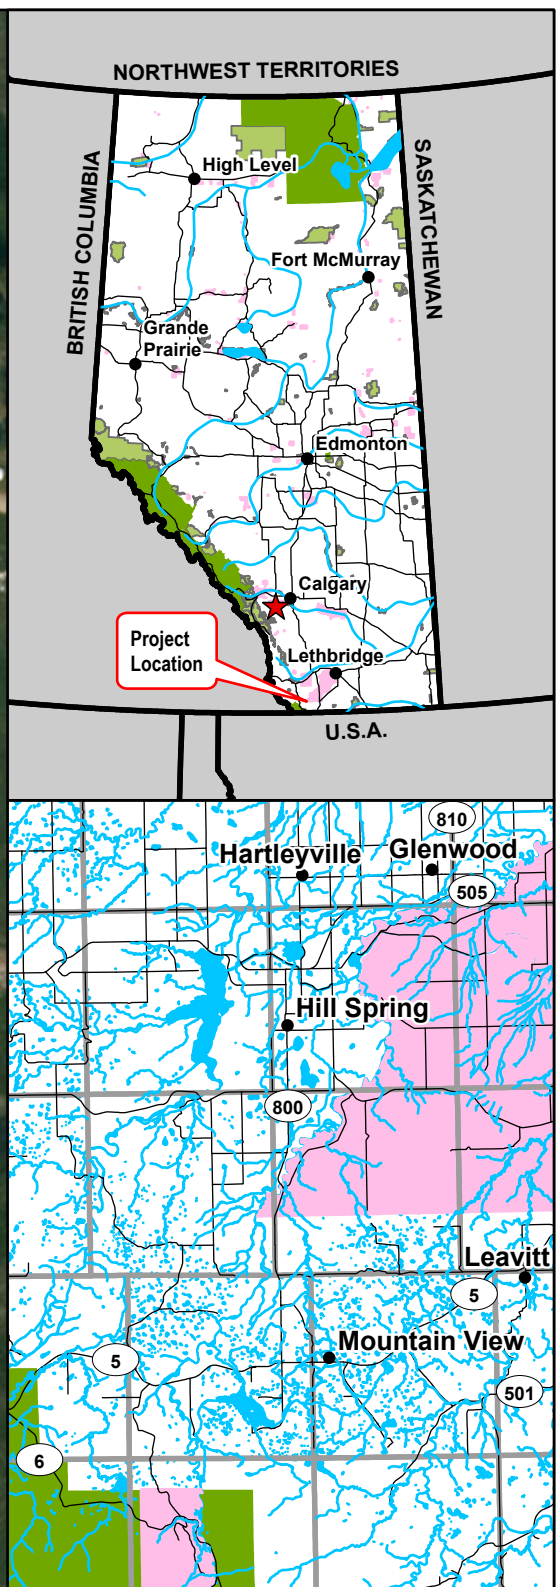
PROJECT SOUTHERN REGION GEOHAZARD RISK MANAGEMENT PROGRAM		
TITLE Site Plan S036 - Belly River Hwy 800:02, km 9.05		
SCALE 1:1,250	PROJECT No. A05116A03	FIG No. 1

Two slope inclinometers (SIs) (SI11-1 and SI11-2) and six vibrating wire piezometers (VWPs) (VW10-6701, VW10-6706, VW12-7899, VW12-7983, VW12-7888, and VW7051) were read at the S036 site in Southern Region on July 7, 2022, by Mr. Guerin White, E.I.T., of Klohn Crippen Berger Ltd. (KCB). These instruments were read as part of the Southern Region Geohazard Risk Management Program (GRMP). The site is located on Hwy 800:02 km 9.05, approximately 9 km south of the Village of Hill Spring, Alberta, on the east side of the Belly River, in the Blood Tribe 148 Reserve. A permit was issued by Blood Tribe Land Management to Mr. White before the instrumentation readings were completed. The approximate site coordinates are 5454362 N, 308507 E (UTM Zone 12, NAD 83) and the legal land description for the site is NW 18-03-27-W4. A site plan is presented in Figure 1.

The geohazard at the S036 site consists of a landslide approximately 200 m long, on the outside (south) bend of the Belly River riverbank. Previous remedial actions at the site include:

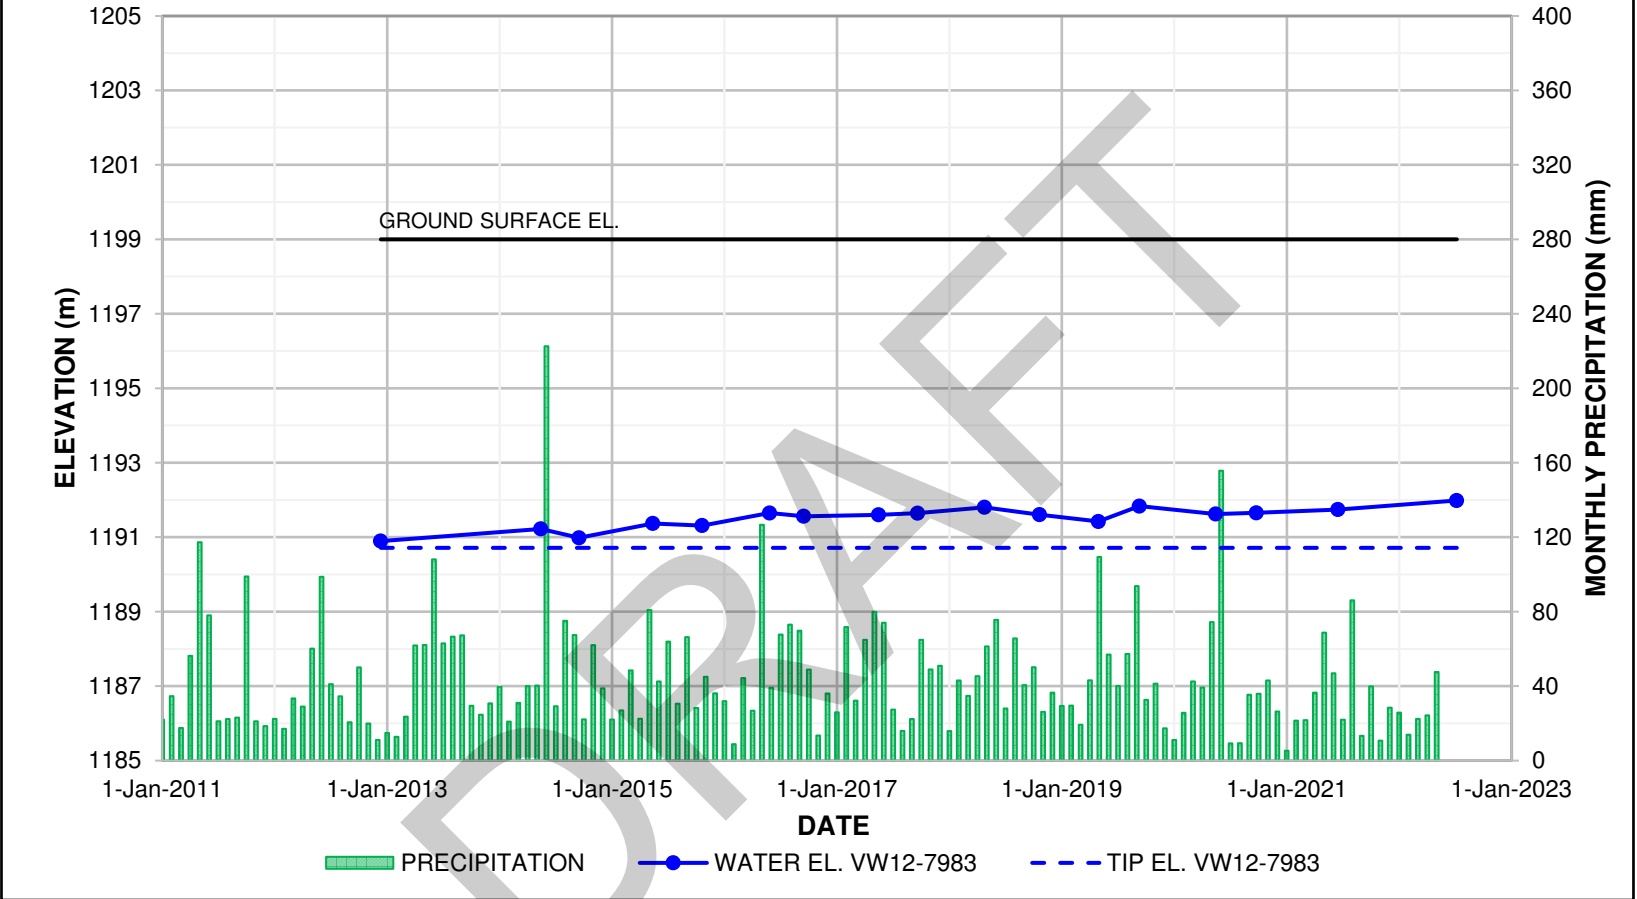
# VW12-7983

Overall, the July 2022 readings of the VWPs were consistent with historical trends observed in these instruments.
