SOUTHERN REGION GRMP SITE INSPECTION FORM

SITE NUMBER AND NAME:	HIGHWAY & KM:	PREVIOUS	INSPECTION DATE:	
S053 Rattlesnake Dip	879:04, 1.00	INSPECTION DATE:	May 31, 2017	
		June 16, 2016	,	
LEGAL DESCRIPTION:	NAD 83 COORDINATES:	RISK ASSESMENT:		
09-20-006-11 W4M	UTM Northing Easting	PF: 9 CF: 2 TO	OTAL: 18	
	12 5481930 467953			
AVERAGE ANNUAL DAILY TF		CONTRACTOR MAINTENANCE AREA (CMA):		
510 (north), (Ref. No. 125050)		24

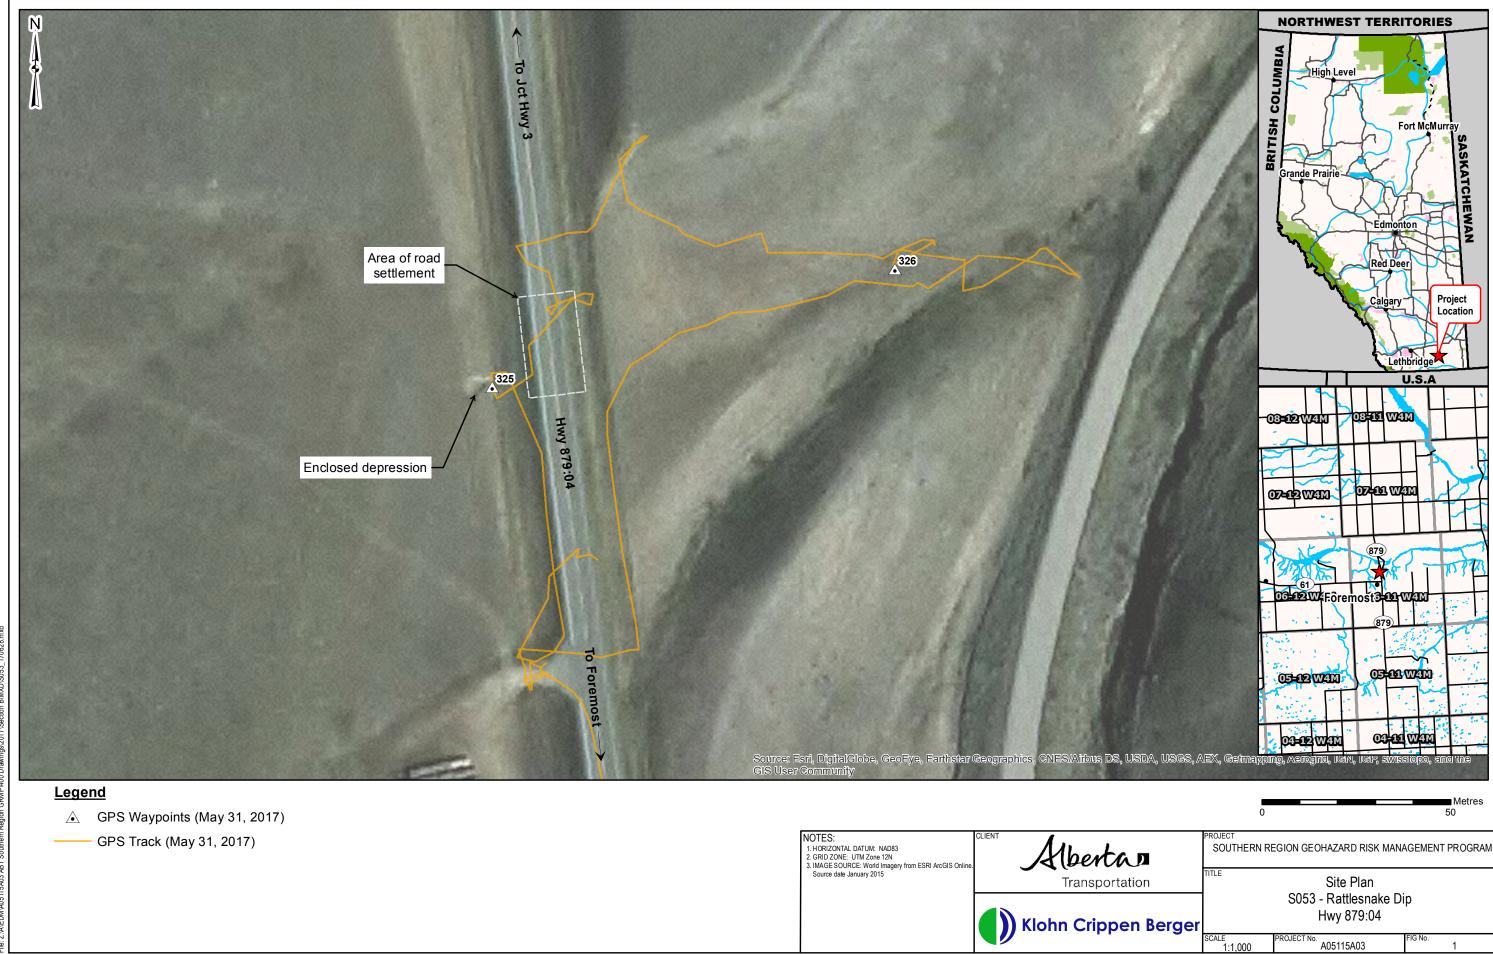
Highway appears to be constructed on an in-filled coulee which is settling. There is evidence of numerous pavement lifts.

Photo 1 Dip in highway, over entire width. Photo was taken facing north on May 31, 2017.

Survey monitoring points in a grid on the pavement surface are being monitored by a surveyor retained by the MCI. The survey data should be provided to AT GRMP staff and KCB for review.
