# SUPERSTRUCTURE INSPECTION AND RATING

### Introduction

- Superstructure is the portion of the bridge above the caps
- Purpose
  - Carry traffic
  - Transfer loads to substructure
- Component materials
  - Timber
  - Concrete
  - Steel
  - Combination

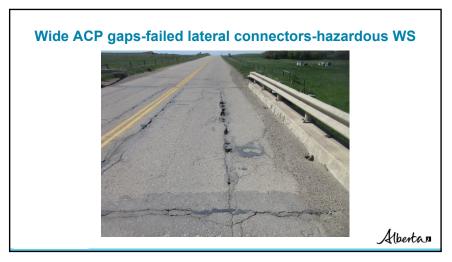
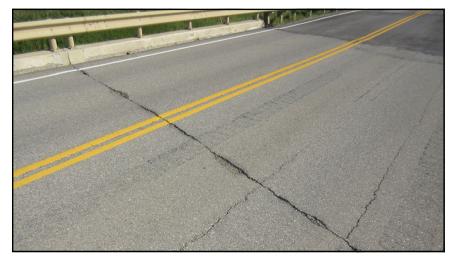
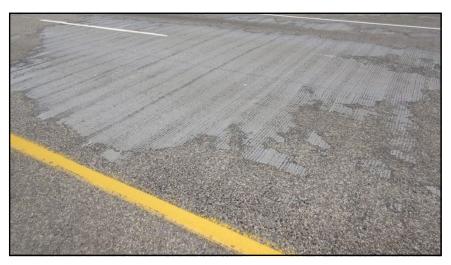
**Wearing Surface**  ACP Cracking between all girders up to 230mm ACP missing on span along PG girders. Worst on NBL. N N Paved over Due to wide gaps up to 230mm wide along girders and missing sections of ACP. N N Paved over. Albertan 43

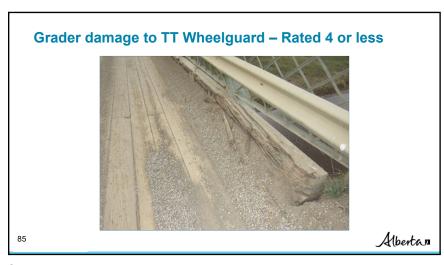
- Look for:
  - Poor anchorage
  - Material defects
  - Missing or loose bolts
  - Poor connections
  - Mis-alignment
  - Collision damageSnowplow damage
  - Missing sections
- · Note any loss of height due to roadway paving or accumulation of dirt or gravel
- Rate according to condition and ability to perform as designed
- Minor splits/cracks rate 5
- Missing/broken sections, blocks, anchors rate 4 or less
