## SUBSTRUCTURE INSPECTION AND RATING

## Introduction

- Portion of the bridge located below the bearings
  Abutments
  Piers

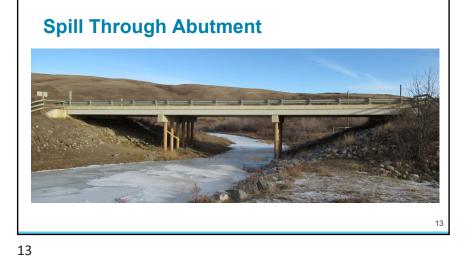
# Spill Through Abutment

- Spill Through Type
  - Intersect the headslope at the cap height
  - No retaining wall (backwalls) below caps
  - Short wings
  - Vulnerable to undermining if headslope not protected with scour protection
  - Susceptible to slumping if headslope too steep or scour at toe
- 12

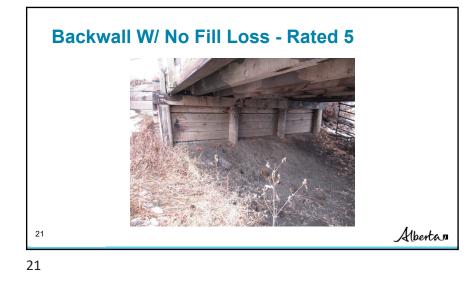
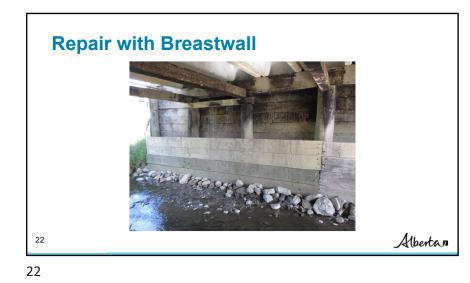
# Backwalls/Breastwalls Loss of Fill Rated 4 Albertan

#### **Backwalls/Breastwalls Ratings** · Rate according to condition and ability to perform as designed (retaining wall) Sheathing bowing out from earth pressure rates 5 provided it is functioning • (retaining fill). Not low enough but no loss of backfill material – rate 5 · Loss of material under sheathing - rate 4 or less · Excessive gaps between the planks allowing infiltration rate 4 or less Decay, broken or missing planks or defects in extended backwall piles - rate • 4 or less 19 Albertan

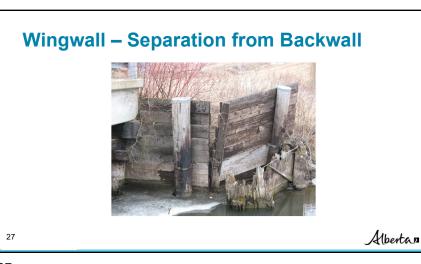
- Applies to abutments only
- Primary function is to retain fillConsist of horizontal or vertical
- driven sheathing attached to pilesWing piles are included in
- wing piles are included in inspection and rating
- Stability and Scour/Erosion are rated separately
- Look for:
  - Material defects
  - Sheathing not installed low
    - enough
      sheathing to be set below the ground level or scour protection installed at the bottom

- Loss of fill material below the wingwall
- Excessive gaps between the planks allowing infiltration
- Sheathing or piles bowing out from earth pressure
- Missing or broken planks or piles
- Missing or damaged tin tops on timber wing piles
  - installed to prevent water from entering cut end and rotting interior of pile
- Proper attachment to backwall loose or missing wing cleat
- Broken or loose anchor tie to pile

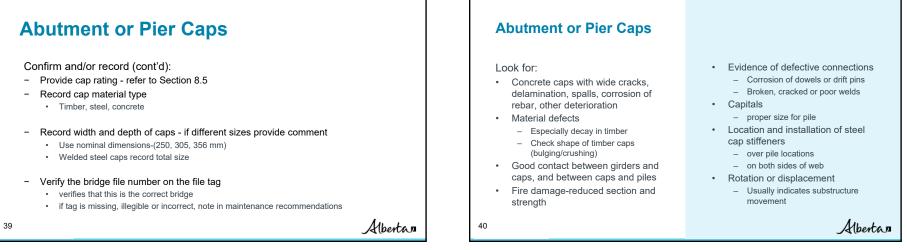
- Timber found on timber pile bents
- Concrete found on concrete or steel
- Steel found on steel or timber pile bents
- Confirm and/or record:
  - Record total number of individual caps at each abut and pier (west:east or south:north) (e.g. 3:3). Steel caps welded together count as 1 cap.
  - Caps < 100 mm depth do not count in total (e.g. plywood crown)
  - Record Detailed rating boxes for caps
  - Record the number of caps not visible in the "N" box
  - Record "0's" if caps are rated 4 or more

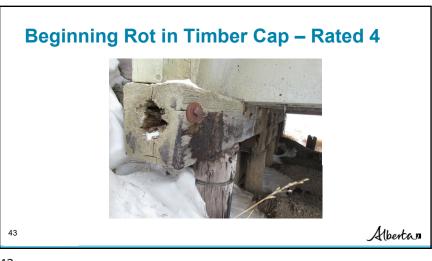
#### **Timber Caps – Abutments or Piers**

#### Decay in timber

- check moist areas contact between girders, piles, sheeting planks
- check cut ends, dowel, drift, and bolt holes
- most often occurs in the cap interior while the treated surface remains sound
- look for discoloration at bottom of caps where moisture leaches out decay byproducts
- look for crushing or bulging especially in high stress areas at piles or under girders
- sound caps with hammer to detect hollow areas
- recommend Level 2 coring if decay present or suspected based on visual clues

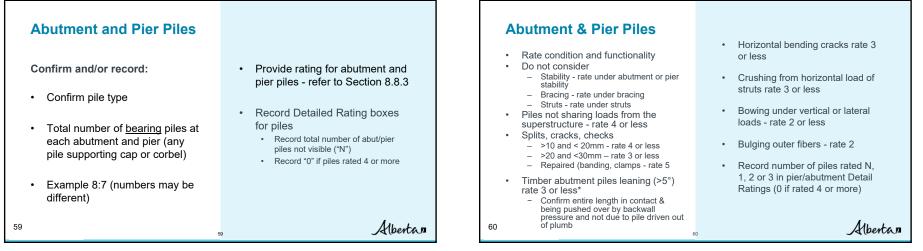
- Cracks, corrosion/loss of section of steel piles
- Collision damage from ice, drift or vehicles (lead pile especially)
- Abrasion from ice or drift
- Bowing due to excessive earth pressure or vertical loads
- Misalignment (out of plumb not sharing loads) due to lateral forces
- Determine if as built (piles driven out of plumb is common) or related to stability
  - · Look for sloped cut on pile top or shims between pile and backwall
- Uneven spacing due to poor construction
- Signs of heaving or settlement. Note in vertical misalignment

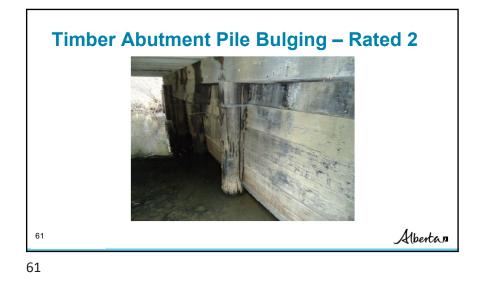
#### **Timber Abutment Pile Bulging – Rated 2**

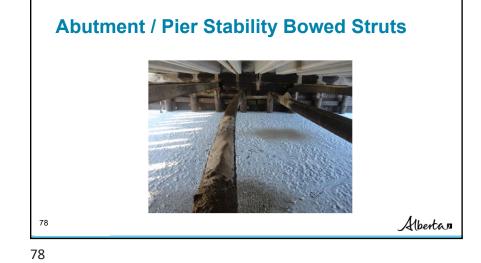
#### **Abutment/Pier Stability**

- Vertical Movement look for:
  - unevenness in superstructure
  - gaps between piles and caps
  - misalignment of structural elements
- Significant scour may not affect stability
- Movement that requires monitoring rate 4 or less
- Movement causing damage to any bridge element rate 4 or less
- Note elements supporting stability with defects (e.g. struts, bracing). Ratings of these elements should be consistent with stability rating
  Mbertan
