ALBERTA TRANSPORTATION

SITE PLAN MID-HILL SLIDE AREA

NORTH CENTRAL (ATHABASCA) 2009 GEOHAZARD ASSESSMENTS NW-1-62-6-W5M NC14 - HWY 661:02 km1.8 N. OF FT. ASSINIBOINE, AB

THURBER PROJECT #15-16-224

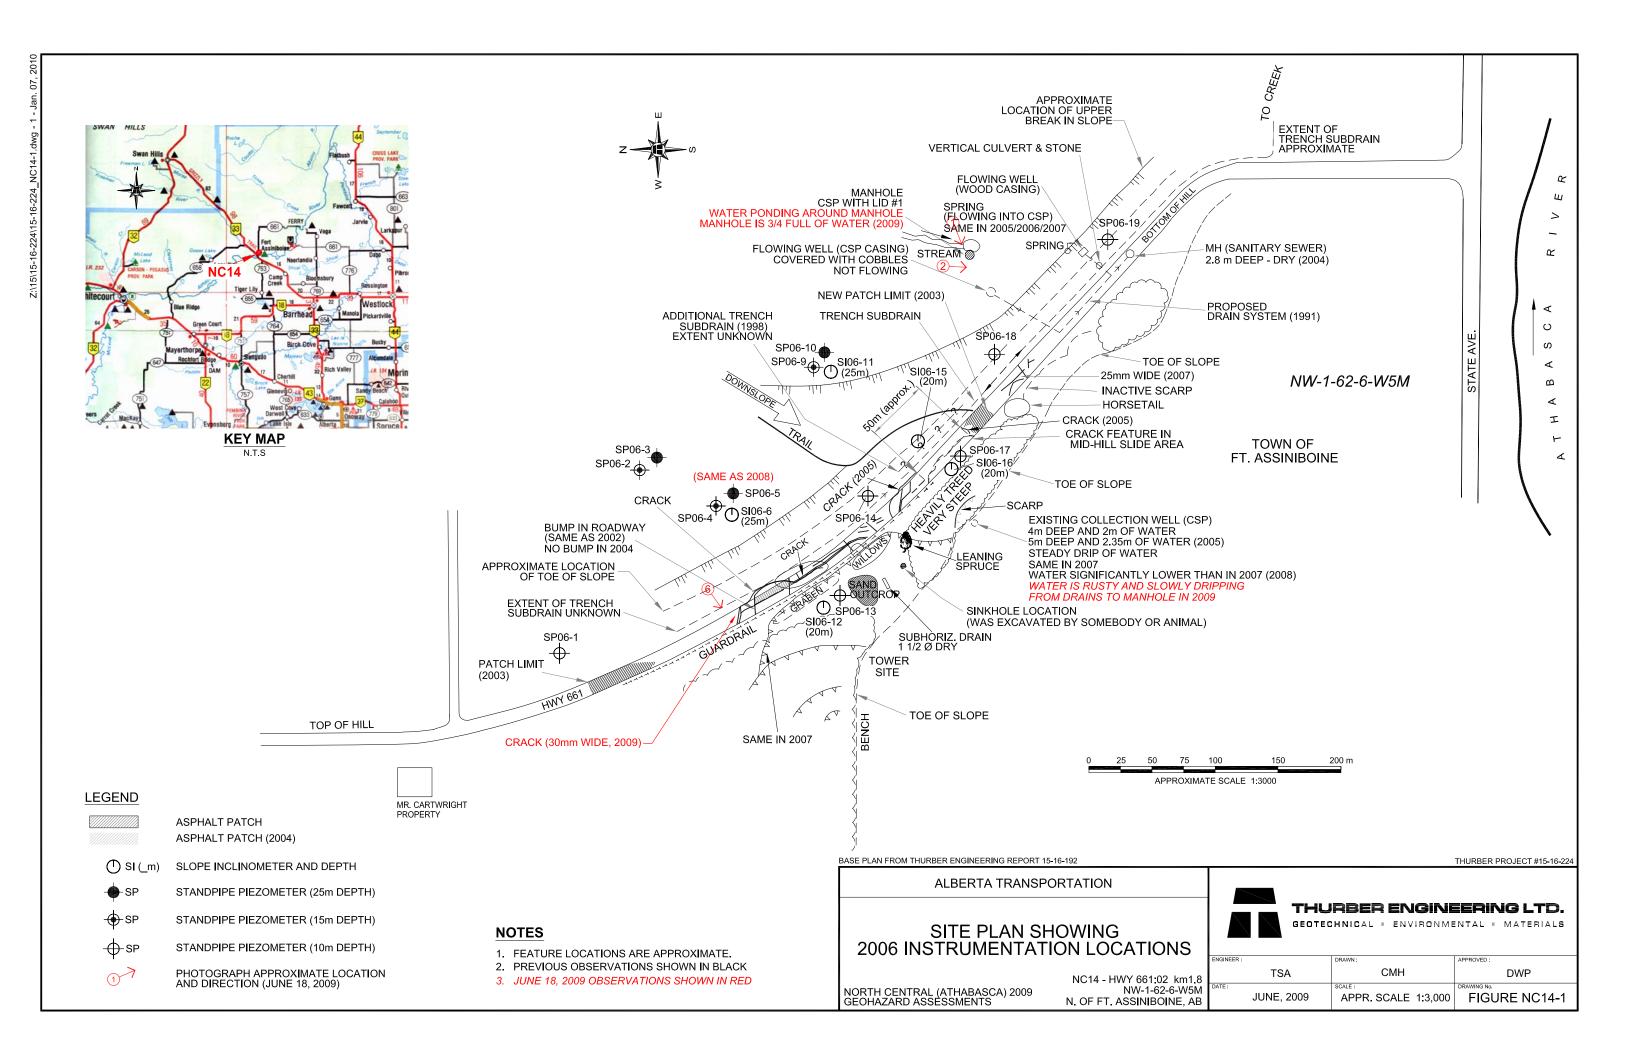
ATE: JUNE, 2009 SCALE: NOT TO SCALE FIGURE NC14-2

- 1. FEATURE LOCATIONS ARE APPROXIMATE.
- 2. PREVIOUS OBSERVATIONS SHOWN IN BLACK
- 3. PREVIOUS CRACK PATTERN WAS COVERED BY NEW (2004) ASPHALT PATCH
- 4. JUNE, 2009 OBSERVATIONS SHOWN IN RED
